Pheasant Branch 2018 Flood Damage Assessment and Five Year Plan

City of Middleton

February 2019

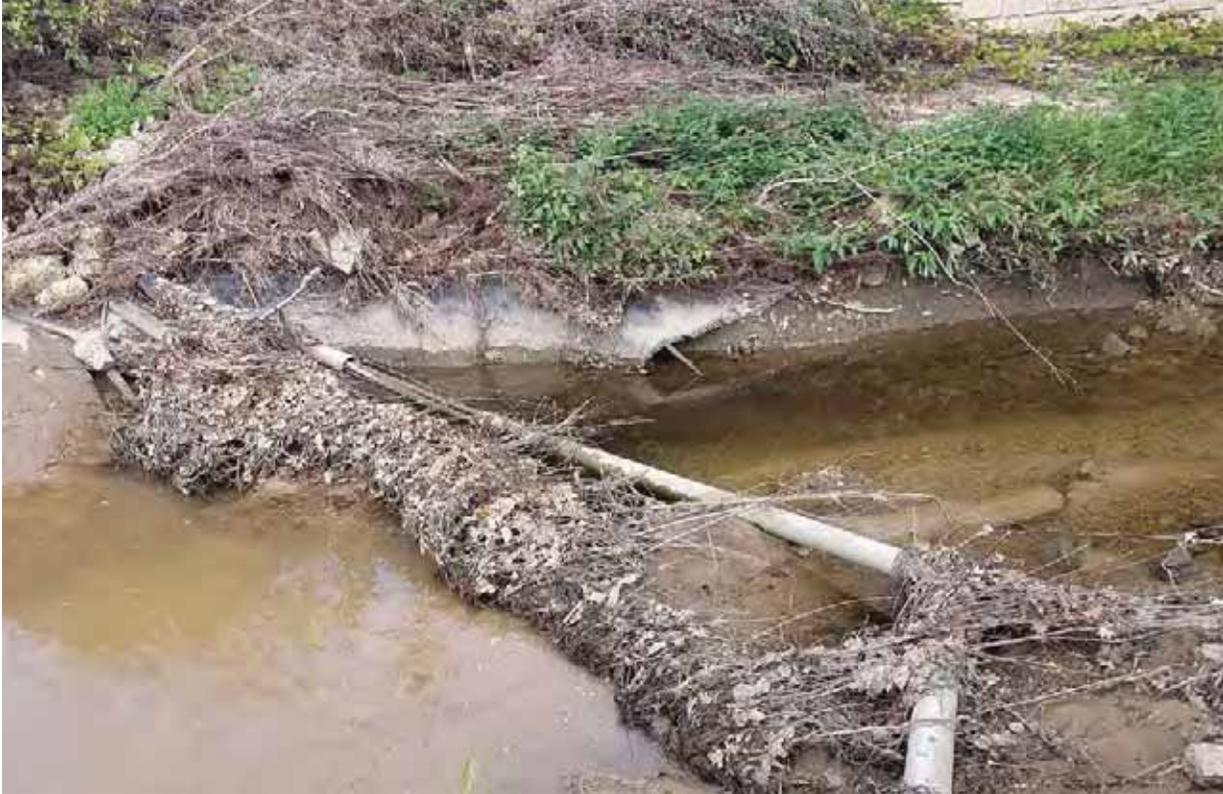
The south fork of Pheasant Branch did sustain damage during the August 2018 flood event including damage to one of the bridges that cross the channel, damage to the porous pavement trail to the east of the channel, and exposure of fiber optic cable lines near the Market St. crossing (Figure 12).

Figure 12: Fiber optic cable lines exposed in south fork Pheasant Branch following August 2018 flood (8/25/18).

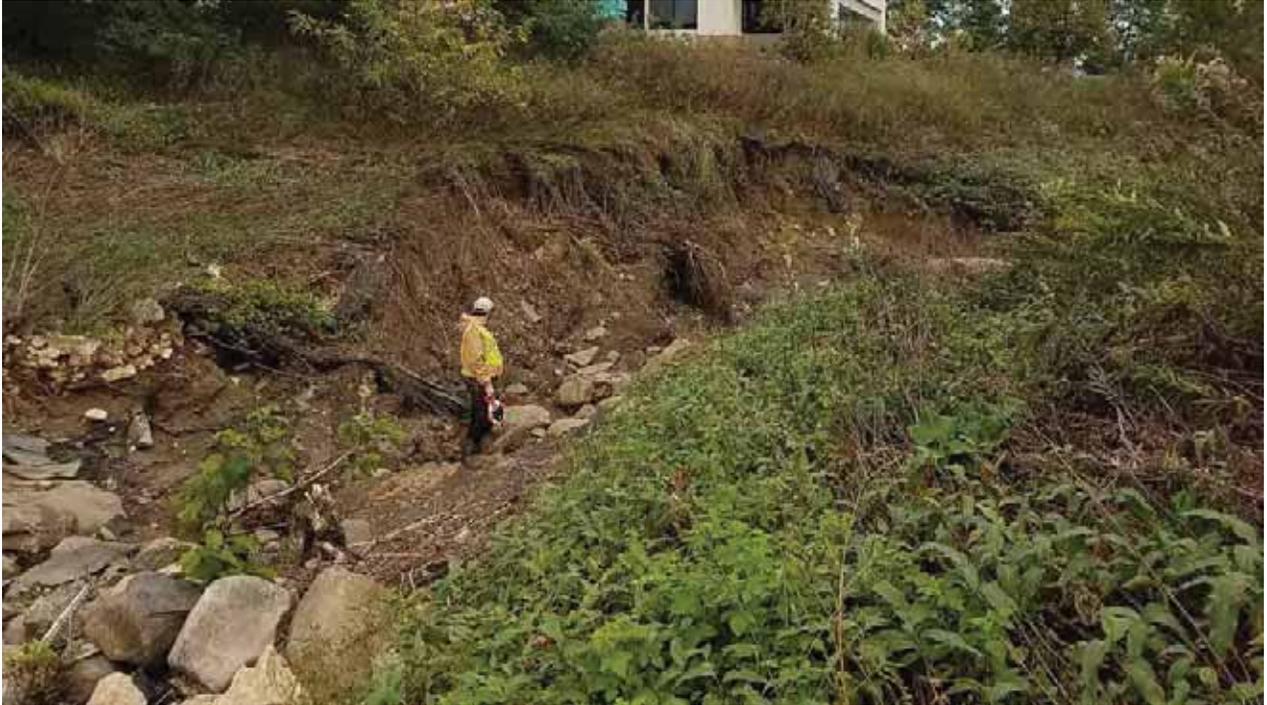
Streambank erosion was also a problem within the south fork of Pheasant following the August 2018 flood. Streambank assessments in this area identified 1,272 linear feet of streambank as having a High potential for future erosion, 373 linear feet of Very High and 387 linear feet showing Extreme streambank erosion (Figure 13).

Figure 13: Post-flood Extreme streambank erosion in the south fork of Pheasant Branch viewing downstream (8/25/18).

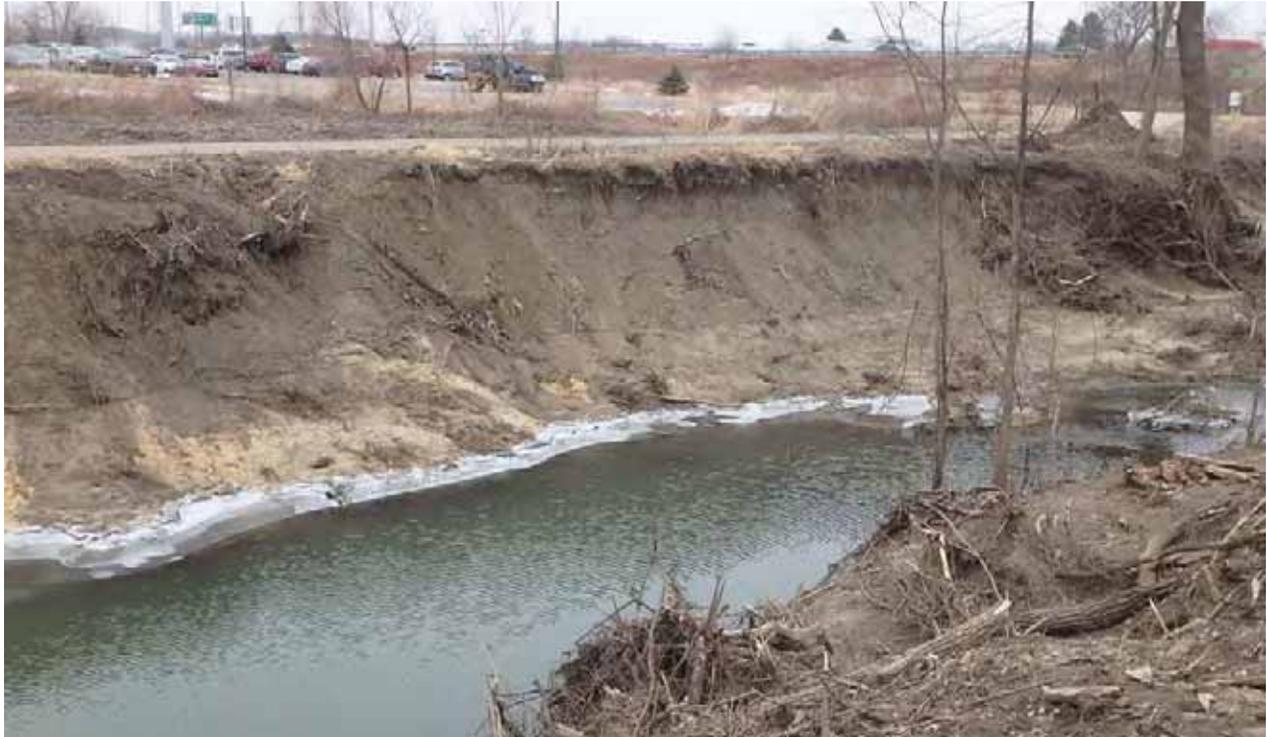
Some areas of the mainstem of Pheasant Branch between the confluence pond and Parmenter St. did experience various degrees of bank erosion following the August 2018 flood event. Streambank assessments within this area determined that approximately 1,520 linear feet of streambanks showed High bank erosion rates with an additional 197 linear feet exhibiting Very High and 264 linear feet of Extreme streambank erosion (Figure 14).

Figure 14: Extreme streambank erosion as a result of August 2018 flood event near Deming Way viewing downstream (1/15/19).

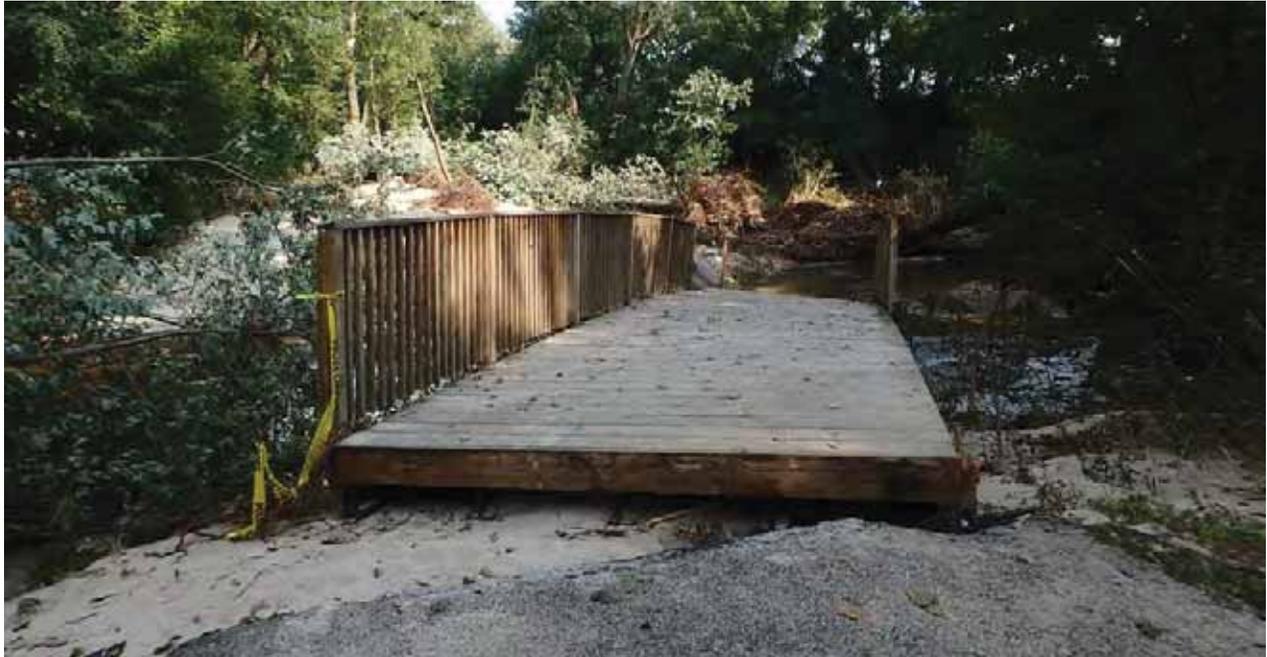
The mainstem of Pheasant Branch between Parmenter St. and Park St. experienced significant damage following the August 2018 flood event. All three pedestrian bridges that cross the channel between Parmenter St. and Park St. were damaged (Figure 15).

Figure 15: Photo of damaged bridge near Parmenter St. following August 2018 flood viewing downstream (8/25/18).

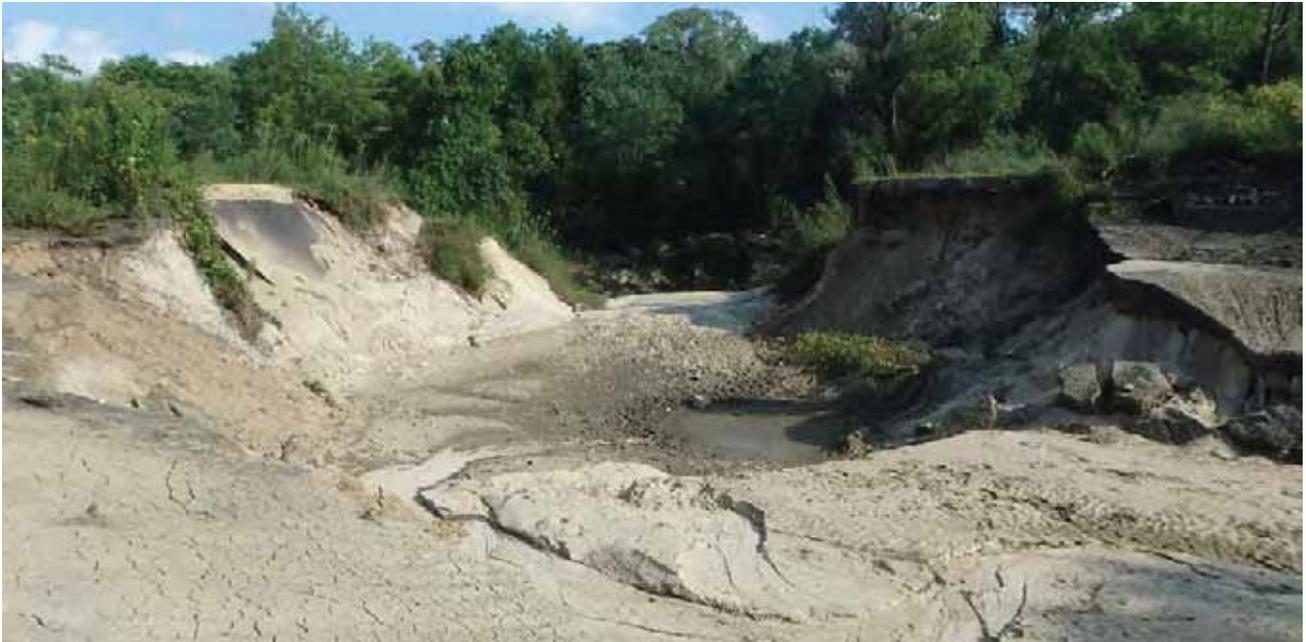
Extensive damage also occurred at the Donna Drive sedimentation pond where flood waters overtopped the pond, eroding the pond bank, causing a complete failure of the pond and stream embankment (Figure 16).

Figure 16: Photo of Donna Dr. sedimentation pond failure following August 2018 flood event (8/25/18).

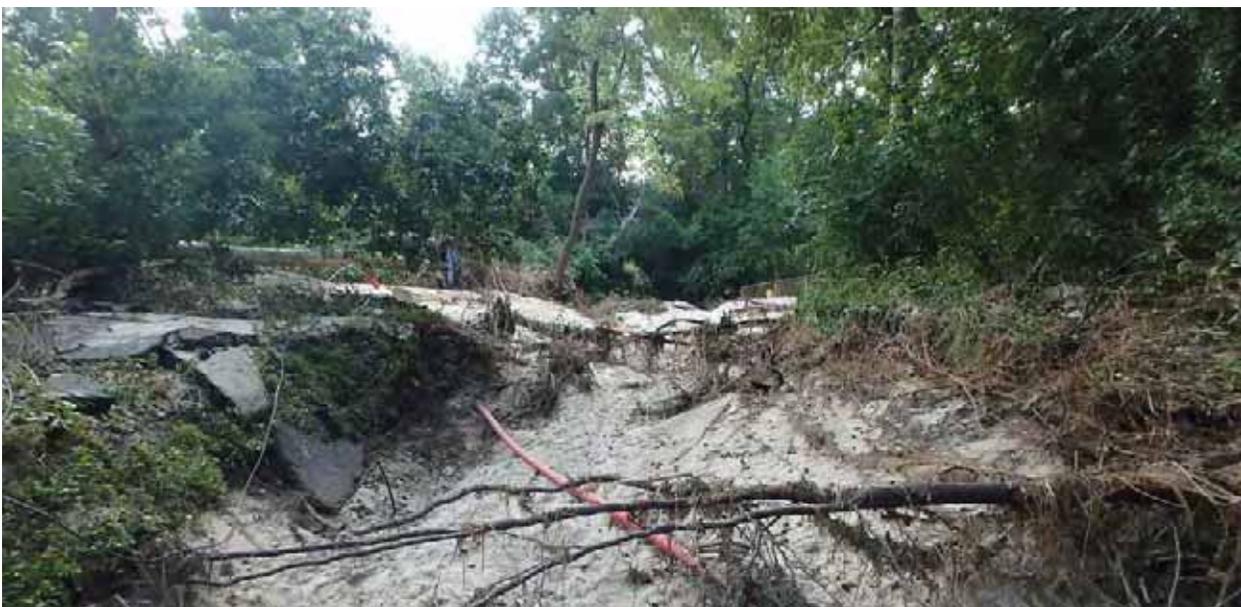
Much of the damage to the existing bridges and streambanks in this section was caused by debris jams consisting of mainly shallow rooted tree species that collapsed into the stream during the August 2018 flood event. Streambank assessments performed through this reach identified approximately 3,892 linear feet of streambanks showing evidence of High bank erosion with 453 linear feet of Very High and 625 linear feet of Extreme streambank erosion. Much of the pedestrian trail system adjacent to Pheasant Branch was also damaged during the August 2018 flood event. These areas will also need to be repaired along with restoration of streambanks and the stream channel in this section of Pheasant Branch (Figure 17).

Figure 17: Photo of pedestrian trail damage between Parmenter St. and Park St. following August 2018 flood event (8/25/18)

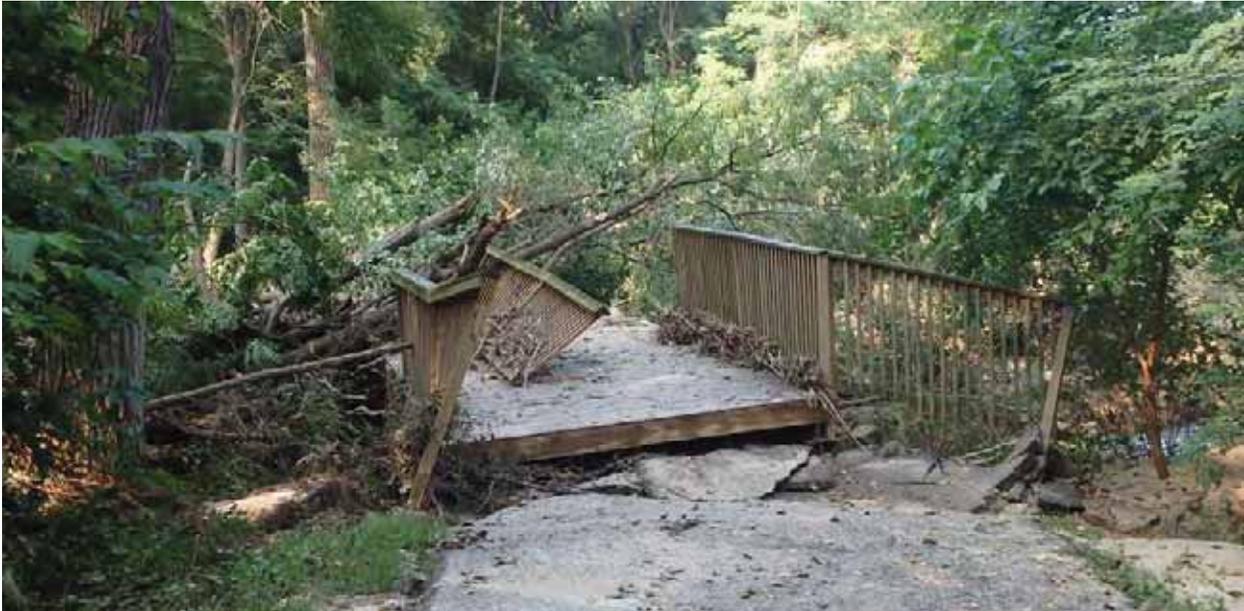
The mainstem of Pheasant Branch between Park St. and Century Ave. experienced significant damage during the August 2018 flood event including damage to each of the three pedestrian bridges located in this section of stream (Figure 18).

Figure 18: Photo of damaged pedestrian bridge between Park St. and Century Ave. following August 2018 flood event (8/25/18).

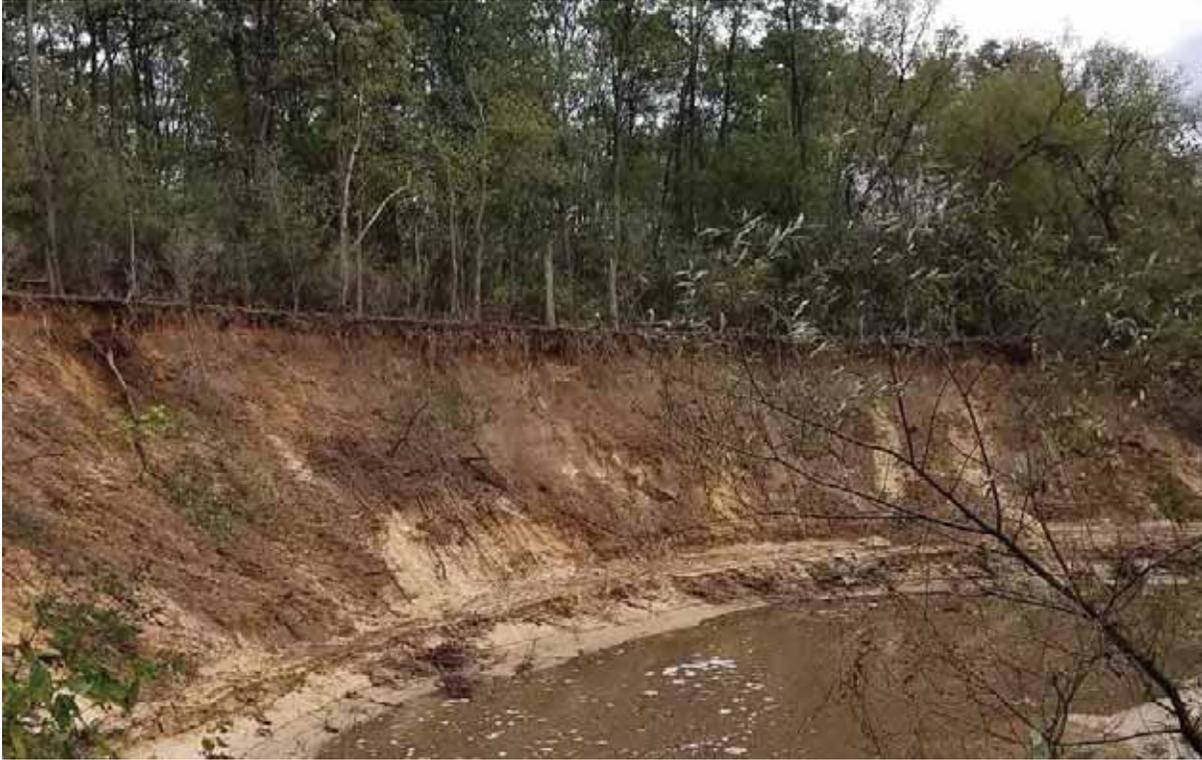
The public trail system within this section was also damaged and well as multiple areas of significant streambank erosion. Streambank erosion assessments within this reach found that approximately 2,289 linear feet of streambank showed evidence of High bank erosion with 503 linear feet of Very High and 444 linear feet showing evidence of Extreme streambank erosion. Much of the damage to bridges and streambanks in this section was caused by debris dams comprised of shallow rooted trees that collapsed into the channel during the August 2018 flood event. Extreme streambank erosion also occurred directly downstream of the Park St. crossing as flood flows were concentrated through the culverts running beneath the roadway (Figure 19).

Figure 19: Photo of Extreme streambank erosion directly downstream of Park St. as a result of August 2018 flood event (10/11/18).

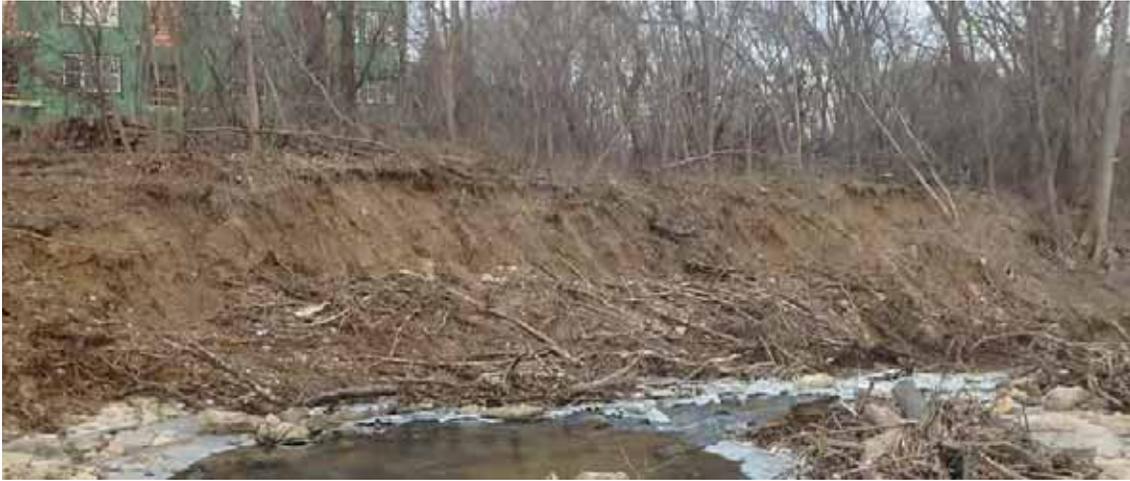
The mainstem of Pheasant Branch north of Century Ave. experienced significant damage during the August 2018 flood event. Streambank erosion assessment through this section of Pheasant Branch showed evidence of High bank erosion on approximately 939 linear feet of streambanks with 1,179 linear of Very High and 636 linear feet of Extreme streambank erosion within this reach (Figure 20).

Figure 20: Extreme streambank erosion directly downstream of Century Ave. as a result of the August 2018 flood event (1/15/19).

This section of Pheasant Branch also experienced severe down-cutting of the main stream channel as a result of the August 2018 flood event. Future restoration efforts in this section will need to address streambank erosion, failing gabions and channel down-cutting moving forward.

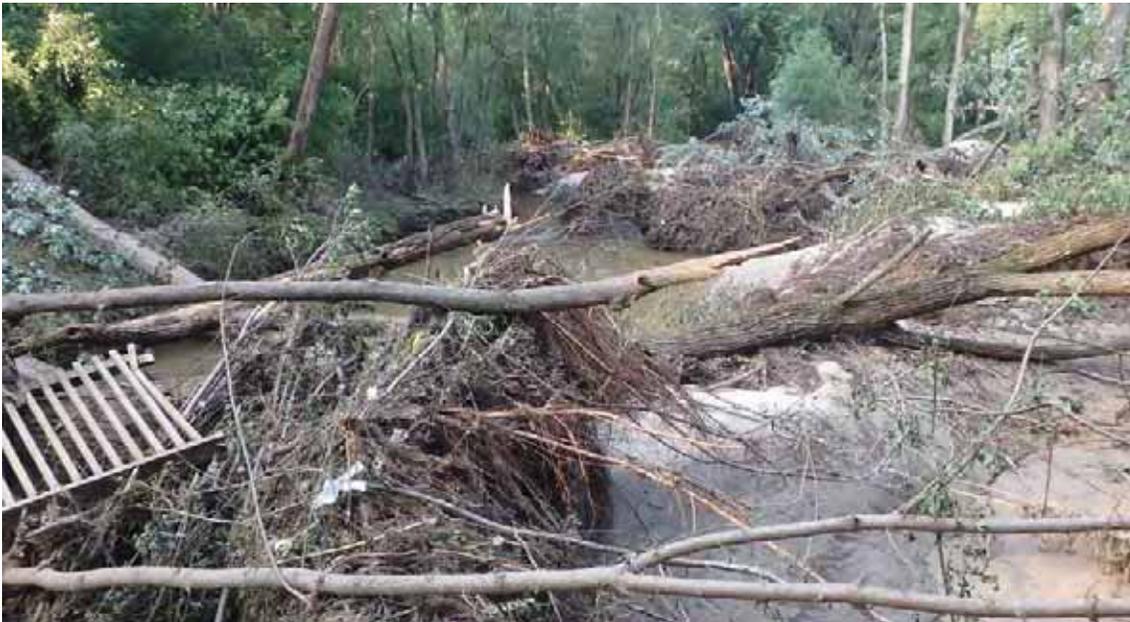
Much of the damage within this section of Pheasant Branch was caused by debris jams from shallow rooted tree species that collapsed into the stream during the August 2018 flood event (Figure 21).

Figure 21: Photo of debris jam located in section of Pheasant Branch north of Century Ave. as a result of August 2018 flood event (8/25/18).

Much of the damage to bridges, infrastructure and streambanks caused by the August 2018 flood event was caused by or exacerbated by shallow rooted tree species such as box elder (*Acer negundo*) that collapsed into the channel during flooding. These early successional or pioneering tree species have shallow root systems that do a poor job of stabilizing streambanks. They do, however, provide shade to streambanks preventing other more beneficial plant species from establishing or occurring. Many remaining box elder and other shallow rooted tree species that didn't collapse into the stream during the August 2018 flood event have been severely undermined and have the potential for causing damage in the future. Future restoration efforts in the south fork and mainstem of Pheasant Branch should take into consideration removing all the down and damaged trees adjacent to the streambank to prevent damage in future flooding events. Trees removed during restoration activities can be stockpiled and re-used to stabilize banks and provide additional stream habitat throughout the Pheasant Branch corridor.

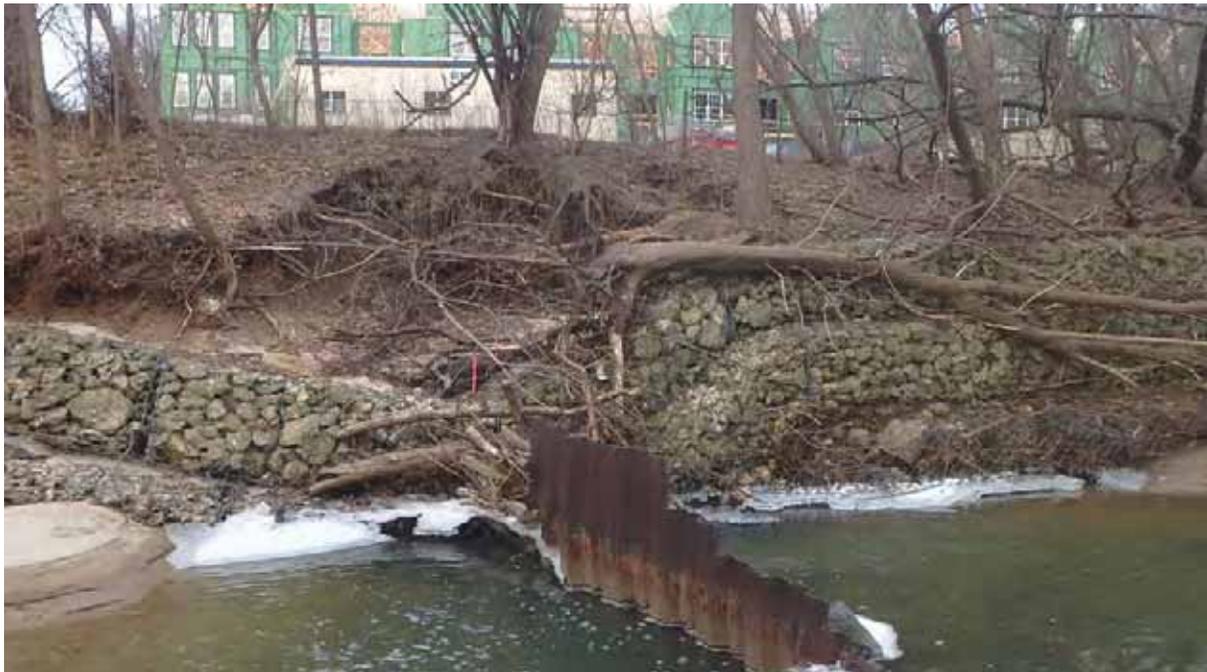
Some of the streambank gabion protection installed directly downstream of Century Ave are also beginning to fail as a result of the August 2018 flood event (Figure 22).

Figure 22: Failing gabion baskets as a result of August 2018 flood event located directly downstream of Century Ave. (1/16/19).

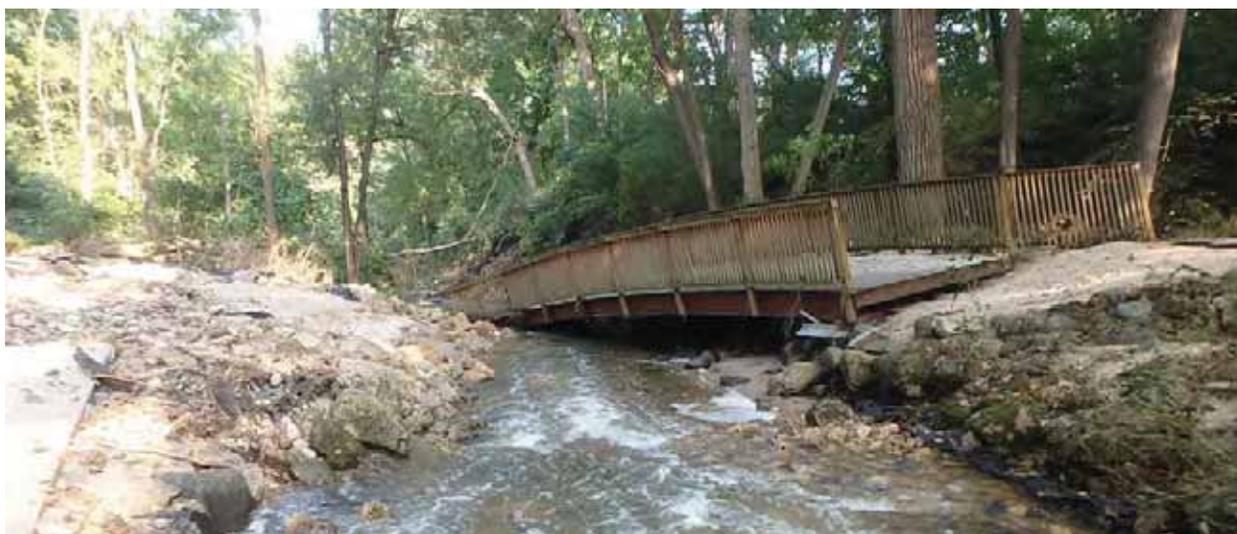
All of the pedestrian bridges throughout the south fork and mainstem of Pheasant Branch sustained some type of damage during the August 2018 flood event (Figure 25).

Figure 25: Damaged bridge between Park St. and Century Ave. as a result of August 2018 flood event (8/25/18).

As budgets allow, it is recommended to give future consideration to lengthen these crossings to allow additional flood flow capacity as well as additional room for debris to pass through them during floods. Additionally there may be opportunities during restoration activities to re-align some sections of the current channel in order to locate bridge crossings over straighter sections of channel instead of near meander bends in the channel where some of the crossings are currently located.

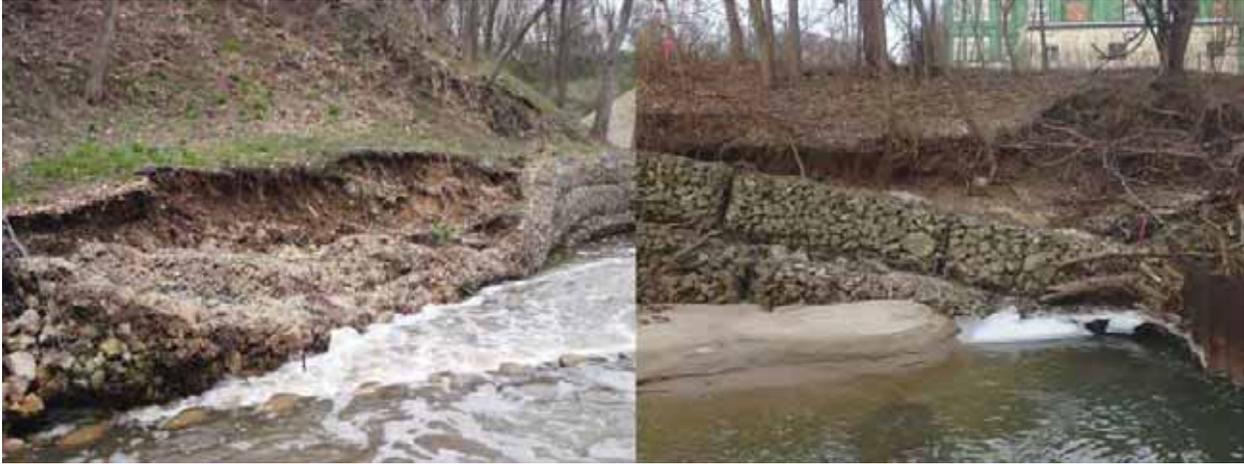
The use of the engineering techniques described above are recommended for use during restoration of damaged areas in the south fork and mainstem of Pheasant Branch as opposed to some of the more traditional “hard armoring” techniques such as sheet-piling and gabion baskets. These “hard armoring” techniques can accelerate local flows causing erosion issues downstream of where they are installed and offer little to no available stream habitat once installed.

Figure 29: Photo of failed gabion baskets between Park St. and Century Ave taken in 2008 (left) and directly downstream of Century Ave taken in 2018 (right).

There may be certain areas with the Pheasant Branch corridor that require additional protection measures (such as where infrastructure or private property are at risk due to bank failure). Installation of sheet-piling may be warranted in these specific areas, yet we recommend that this “hard-armoring” be buried within the slope so a more natural look as well as additional streambank habitat can still be installed in these areas.

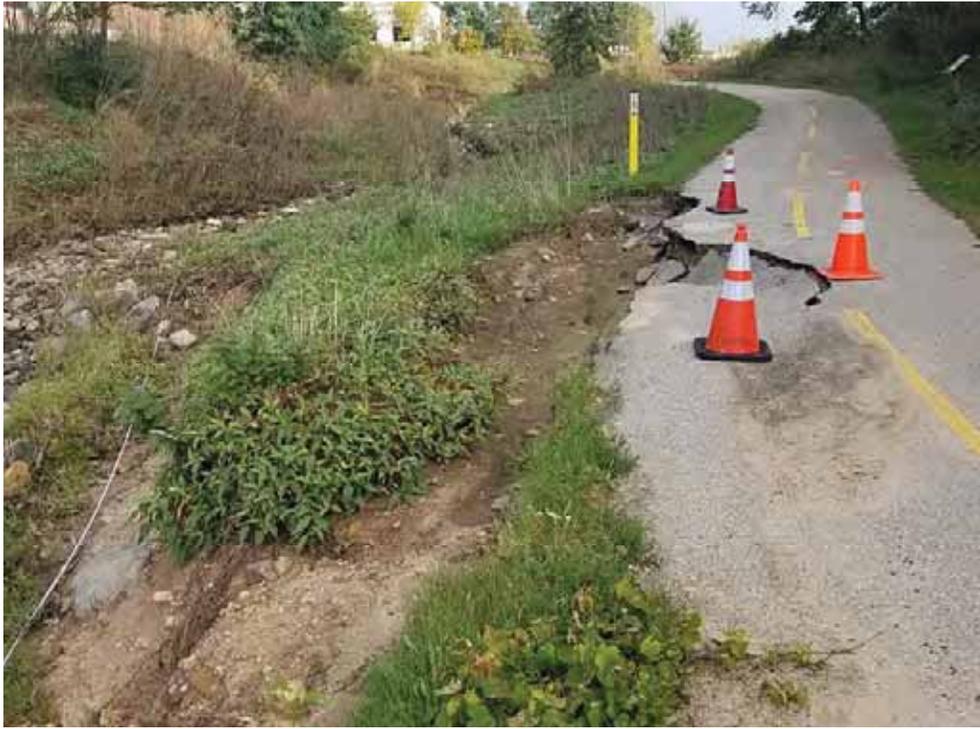
Photo 3. Photo of damage to walking path near south fork channel looking downstream (October 16, 2018).

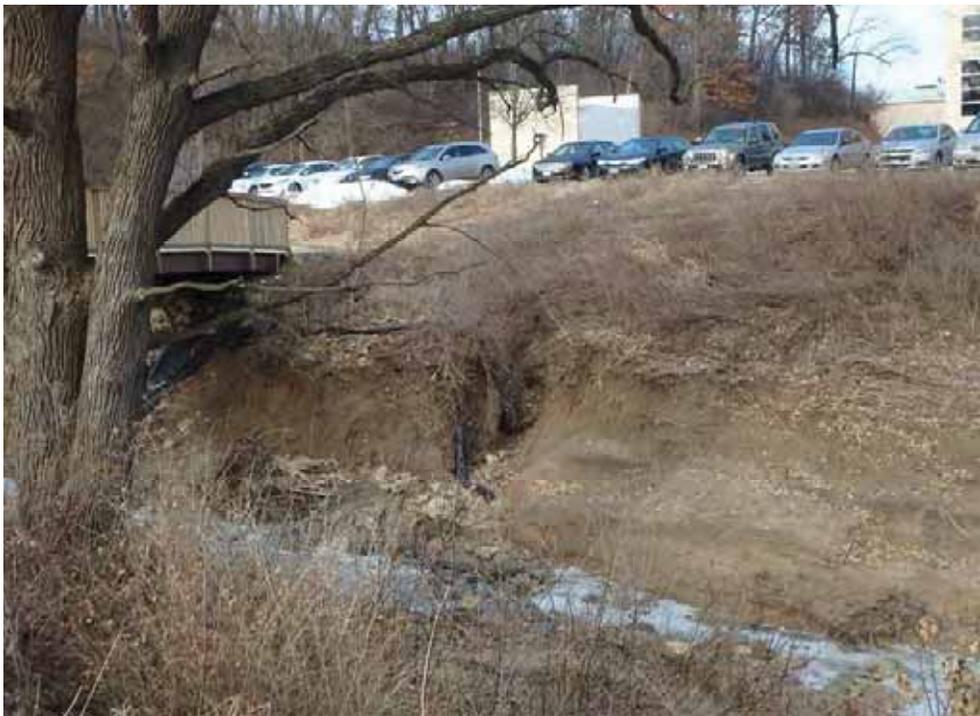
Photo 4. Photo viewing upstream of streambank erosion under a pedestrian bridge abutment caused by August 2018 flood event (January 16, 2019).

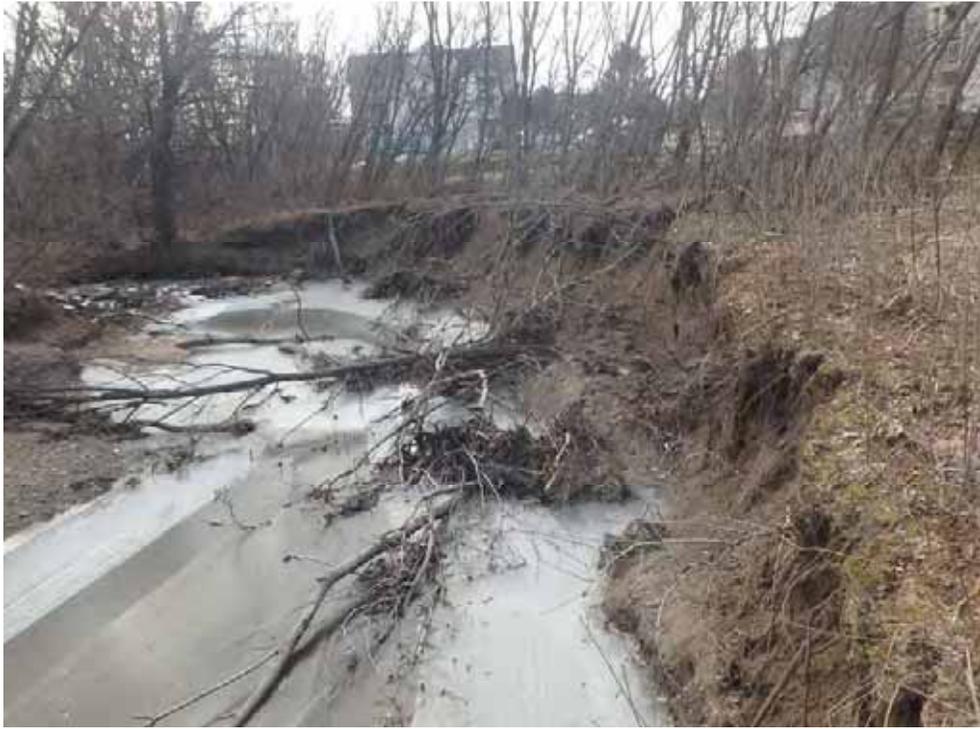
Photo 5. Photo of streambank erosion on the south fork of Pheasant Branch viewing upstream (January 16, 2019).

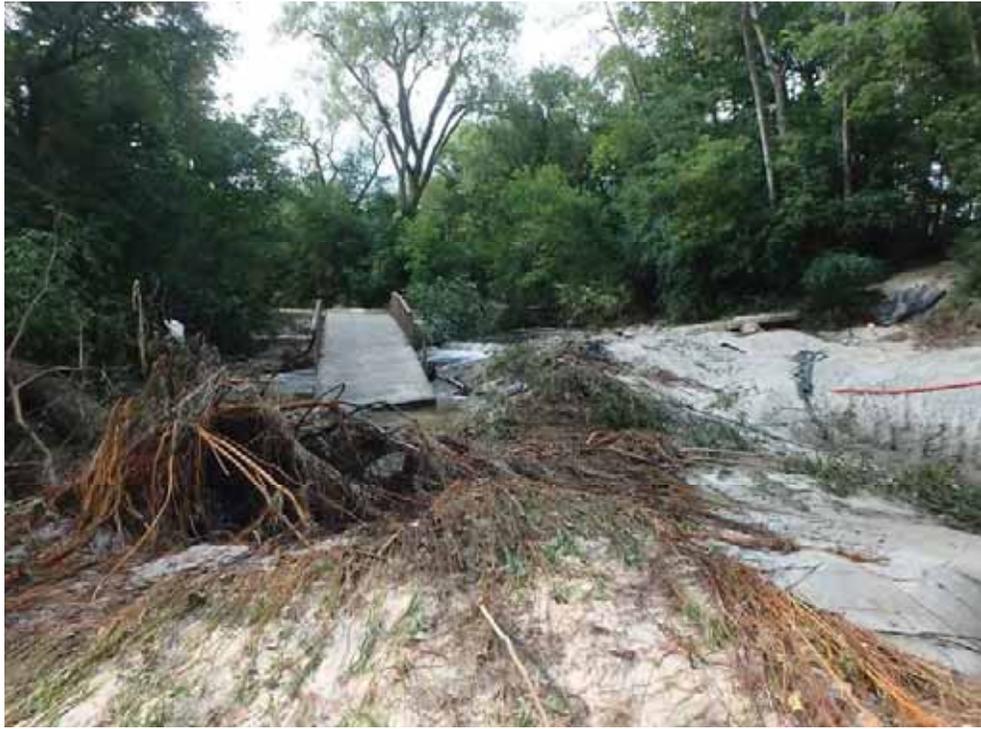
Photo 15. Photo of damaged bridge near Parmenter Street on the mainstem of Pheasant Branch viewing upstream (August 25, 2018).

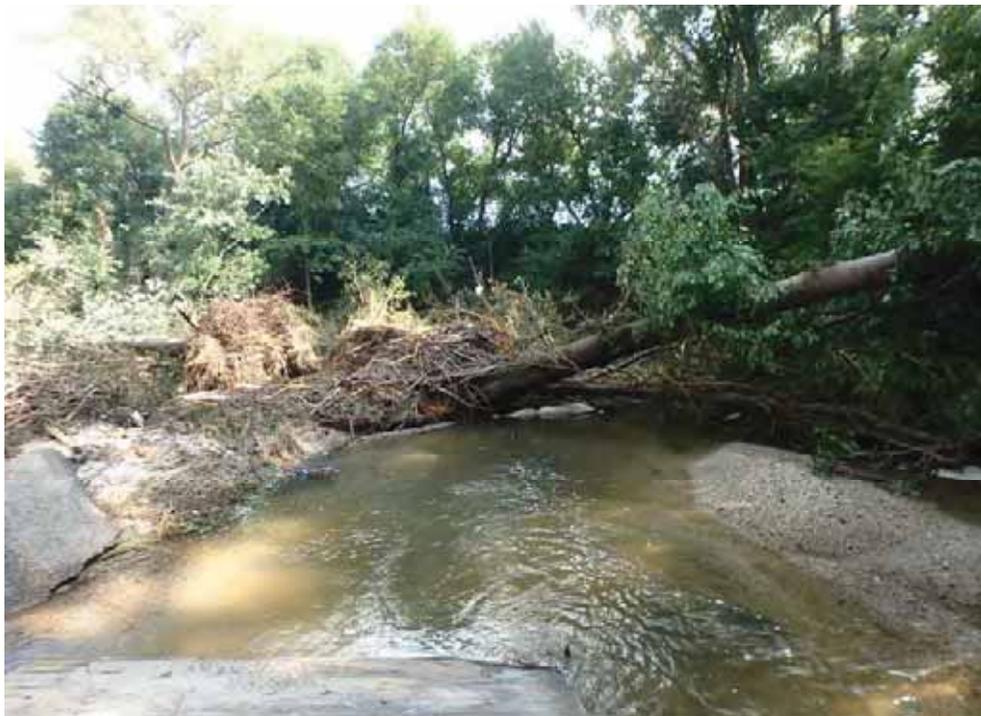
Photo 16. Photo of debris jam on the mainstem of Pheasant Branch near Parmenter Street viewing downstream (August 25, 2018).

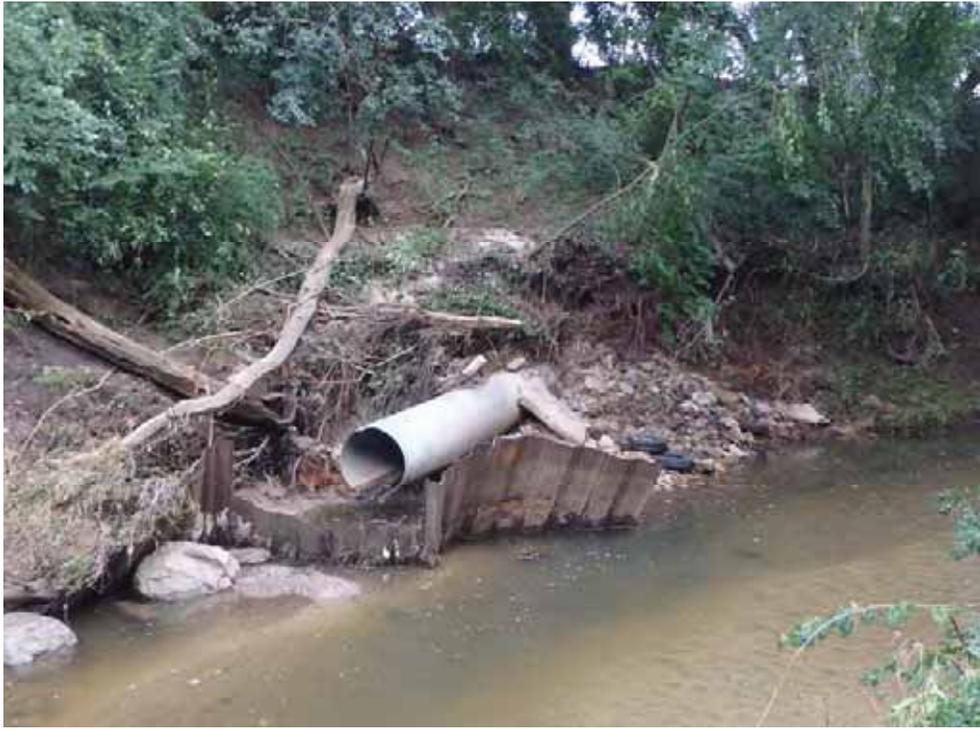
Photo 17. Photo of damaged stormwater outlet on the mainstem of Pheasant Branch viewing upstream (August 25, 2018).

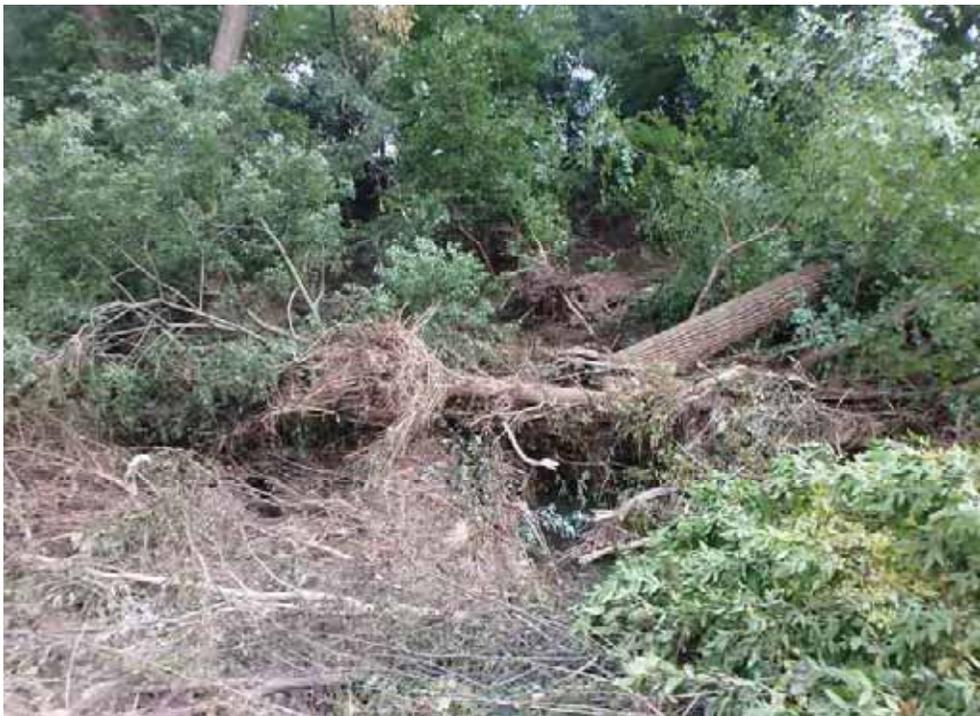
Photo 18. Photo of debris jam on the mainstem of Pheasant Branch viewing upstream (August 25, 2018).

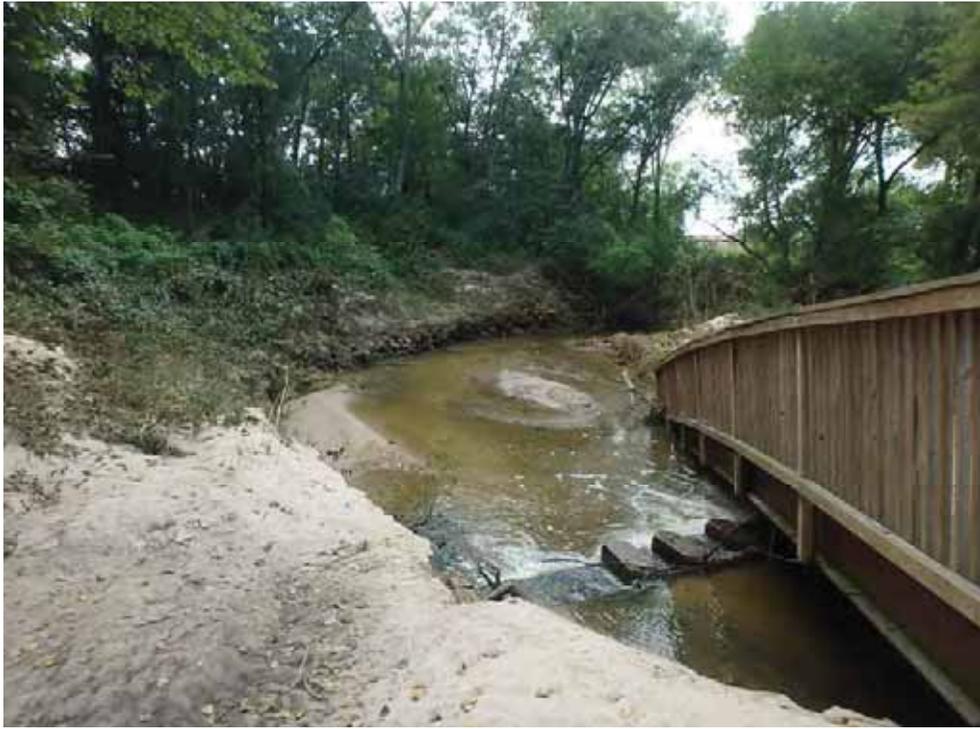
Photo 19. Photo of damaged bridge and intact rootwad composites on the mainstem of Pheasant Branch viewing downstream (August 25, 2018).

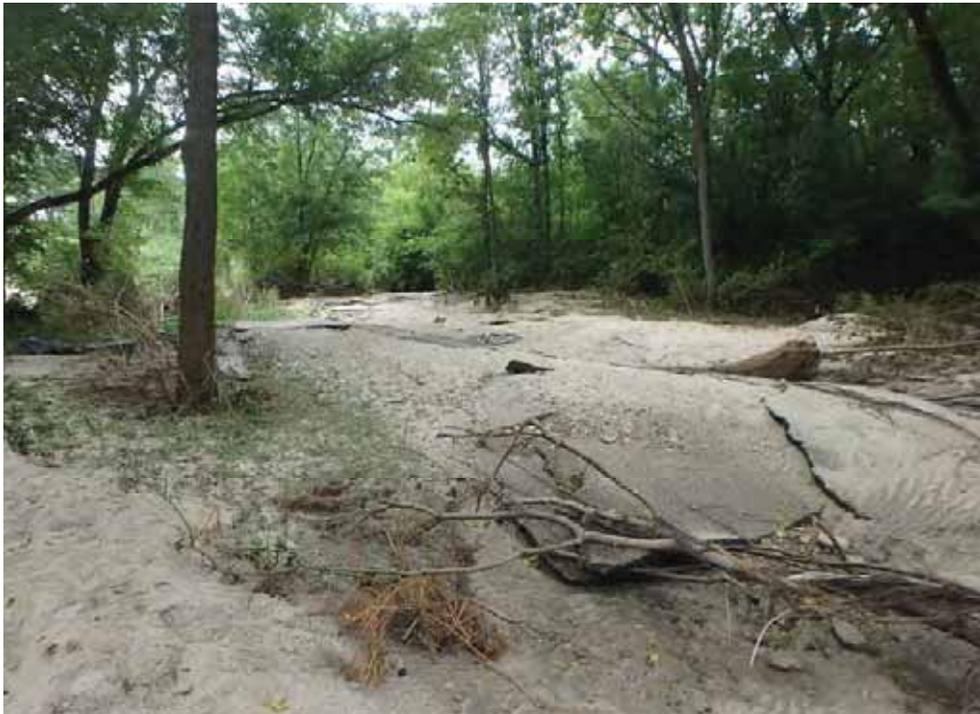
Photo 20. Photo of damaged trail and sediment deposited on trail (August 25, 2018).

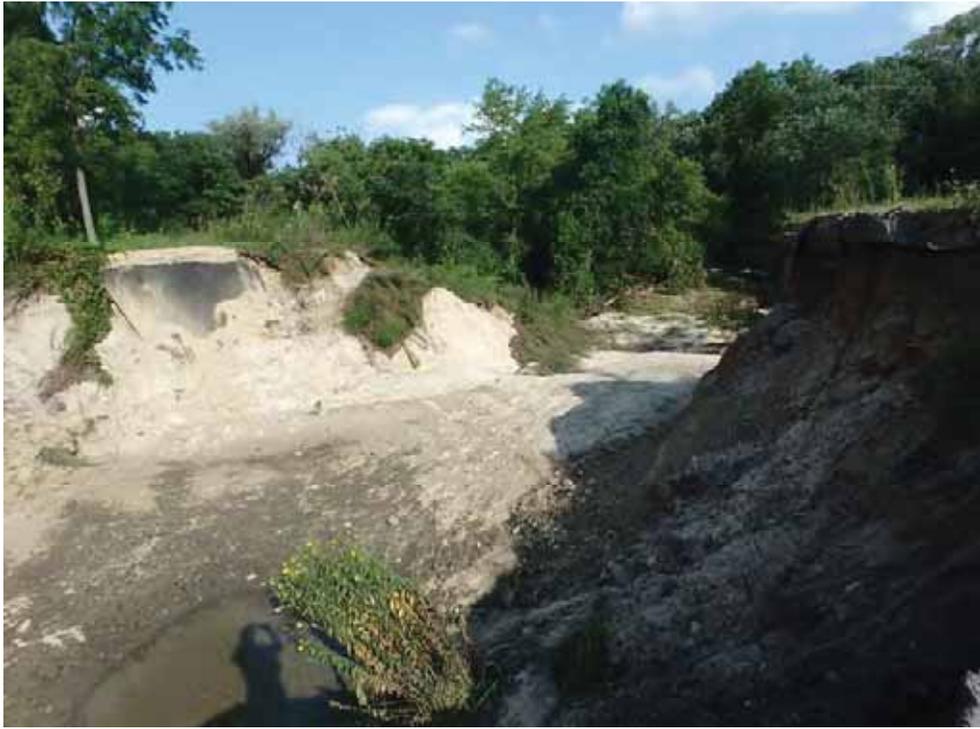
Photo 21. Photo of collapsed bank and Donna Drive sedimentation pond failure on mainstem Pheasant Branch (August 25, 2018).

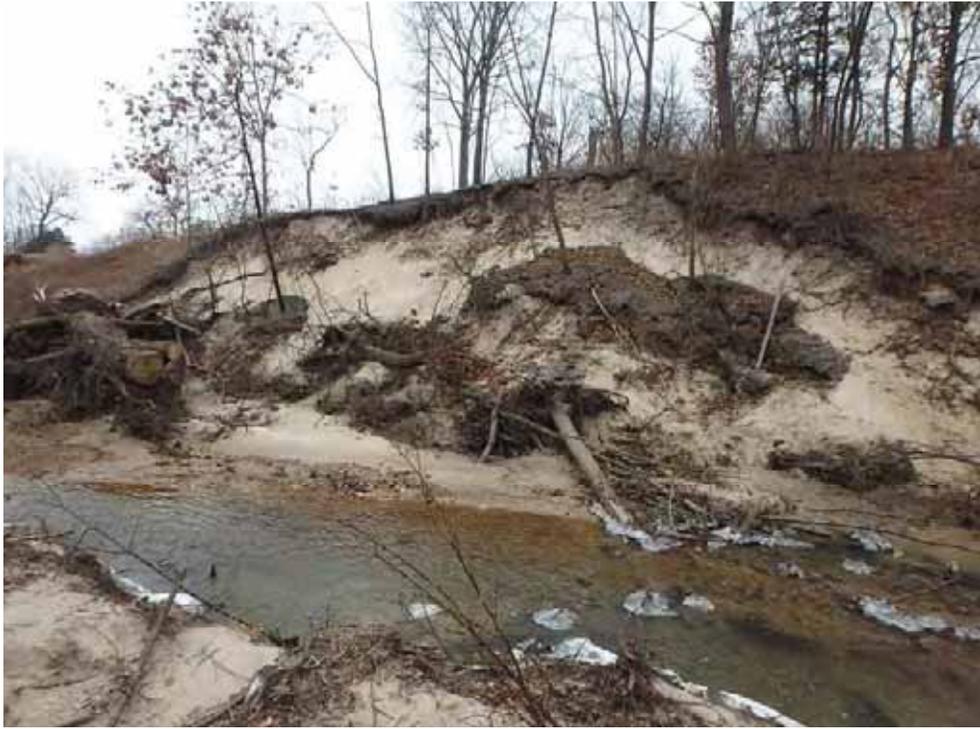
Photo 23. Photo of collapsed bank directly downstream of Donna Drive sedimentation pond failure on mainstem Pheasant Branch viewing upstream (January 15, 2019).

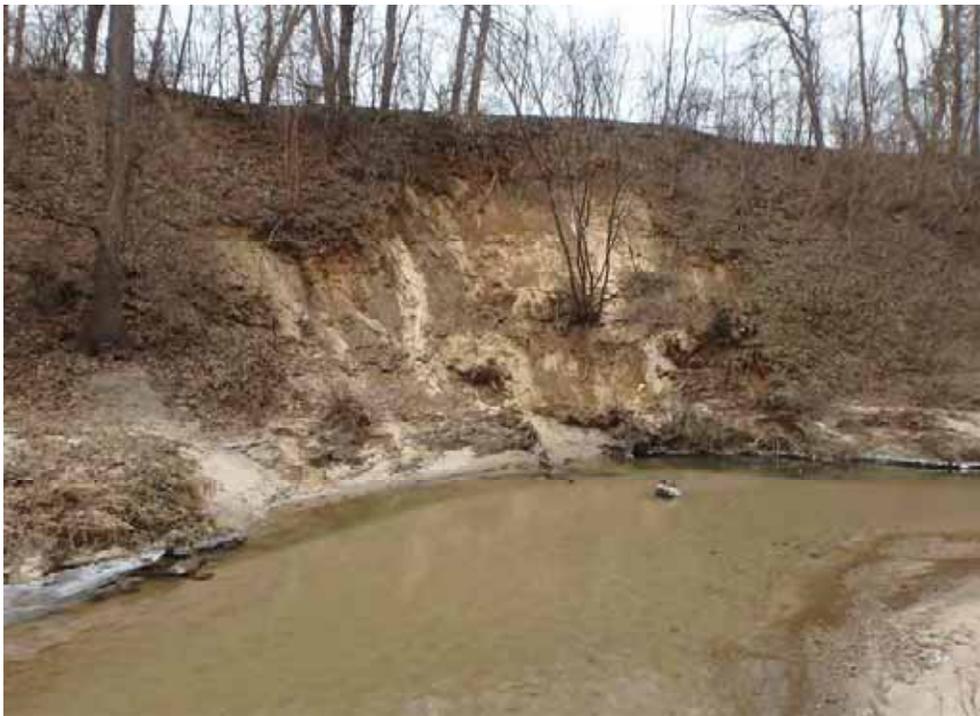
Photo 24. Photo of collapsed bank near Park Street on mainstem of Pheasant Branch viewing downstream (January 15, 2019).

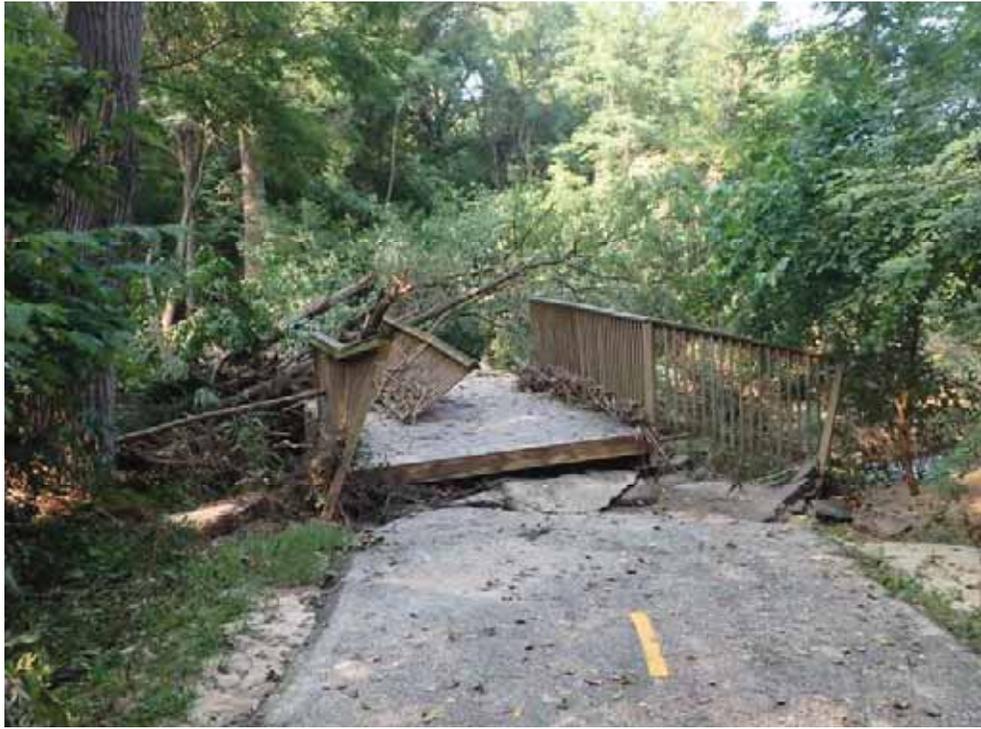
Photo 29. Photo of bridge damage downstream of Park Street on mainstem Pheasant Branch (August 25, 2018).

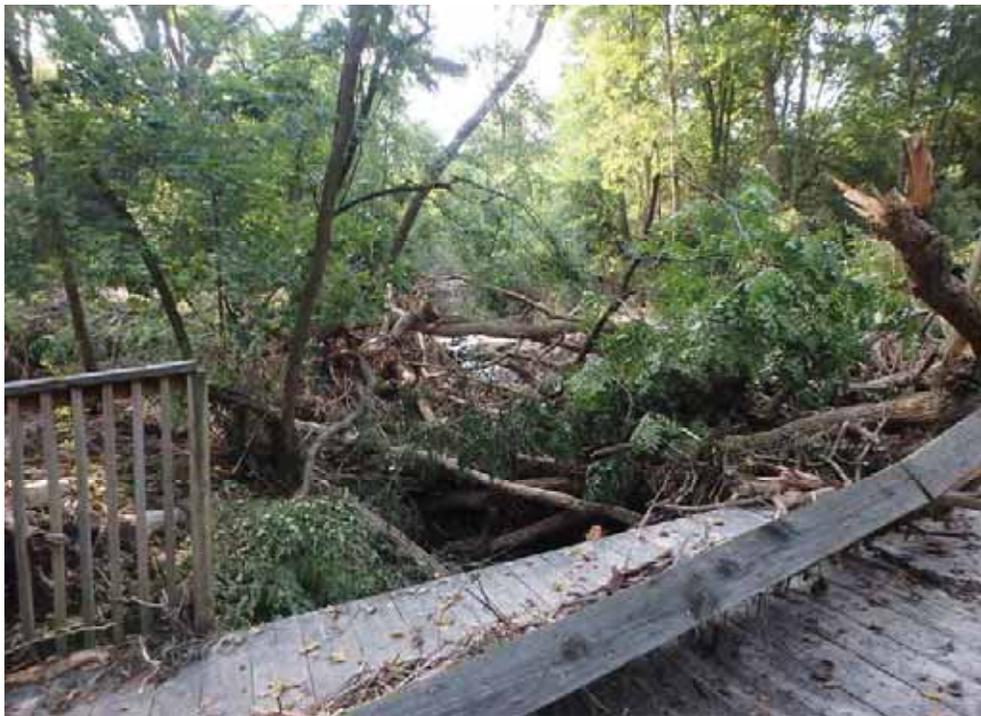
Photo 30. Photo of debris dam upstream of damaged bridge near Park Street on mainstem of Pheasant Branch (August 25, 2018).
