Pheasant Branch 2018 Flood Damage Assessment and Five Year Plan

City of Middleton

February 2019

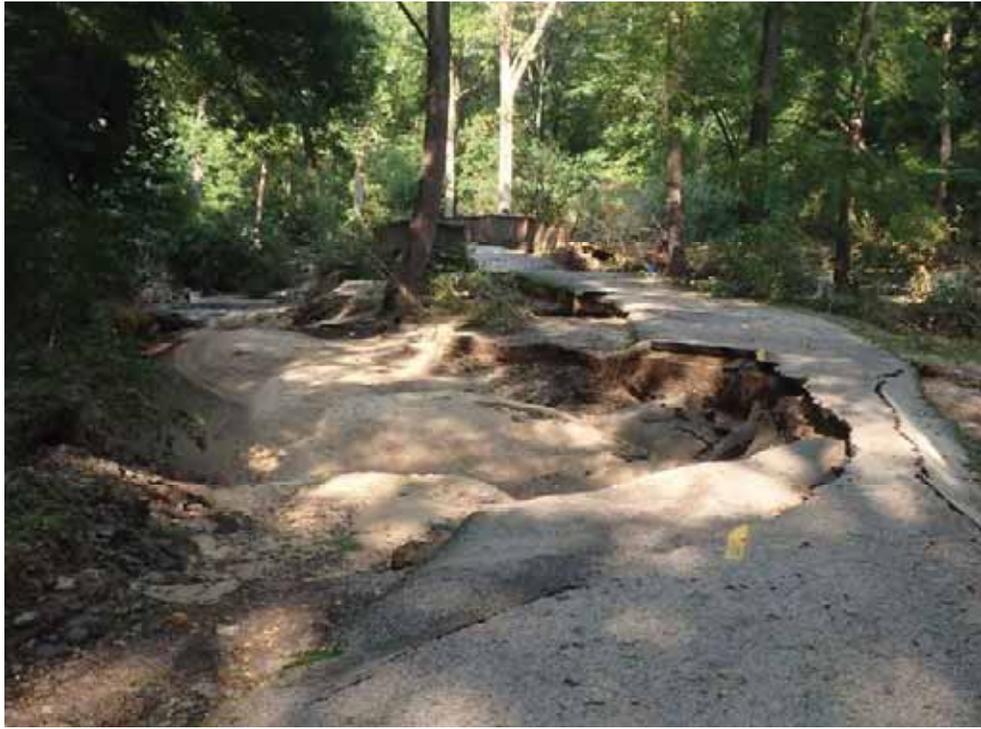
Photo 31. Photo of trail damage downstream of Park Street (August 25, 2018).

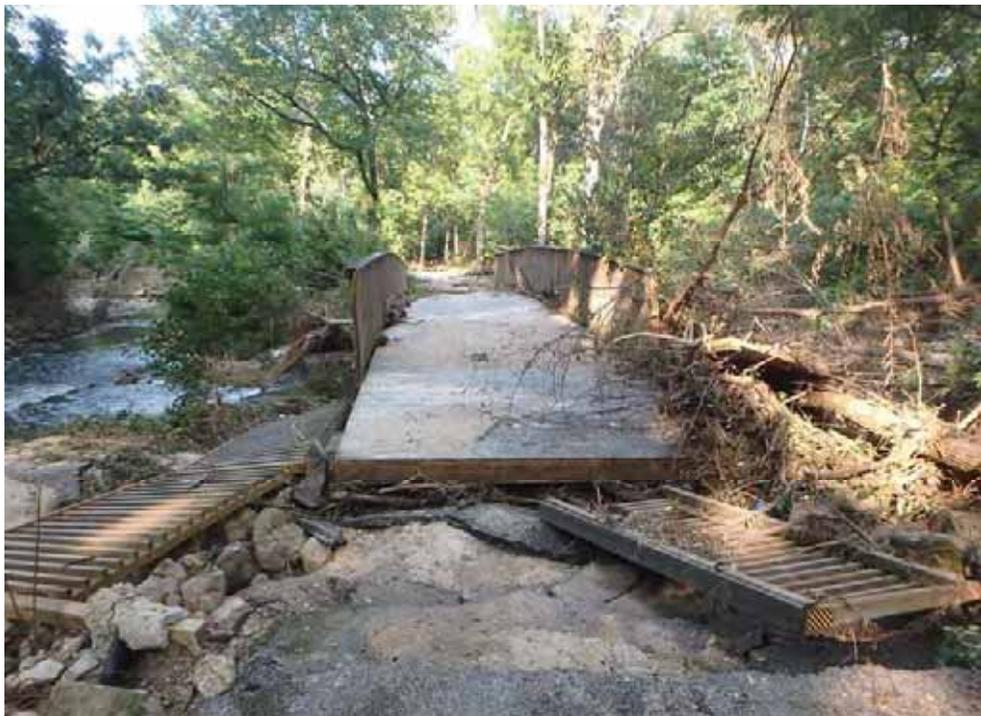
Photo 32. Photo of second damaged bridge and debris jam between Park Street and Century Avenue on mainstem of Pheasant Branch (August 25, 2018).

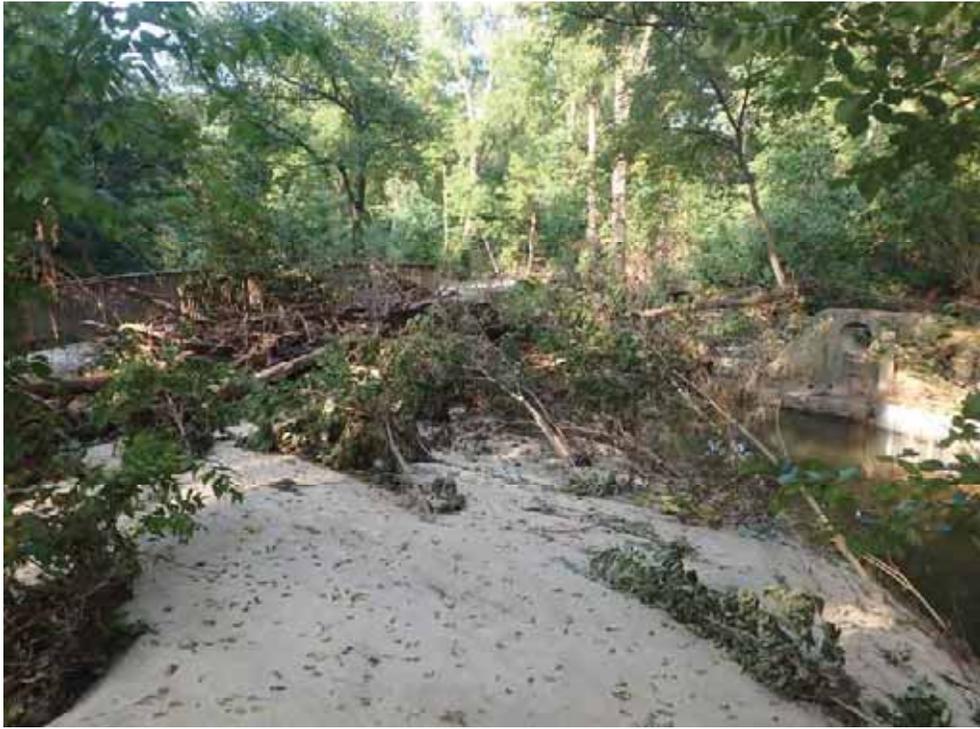
Photo 33. Photo of debris jam upstream of bridge crossing on mainstem of Pheasant Branch (August 25, 2018).

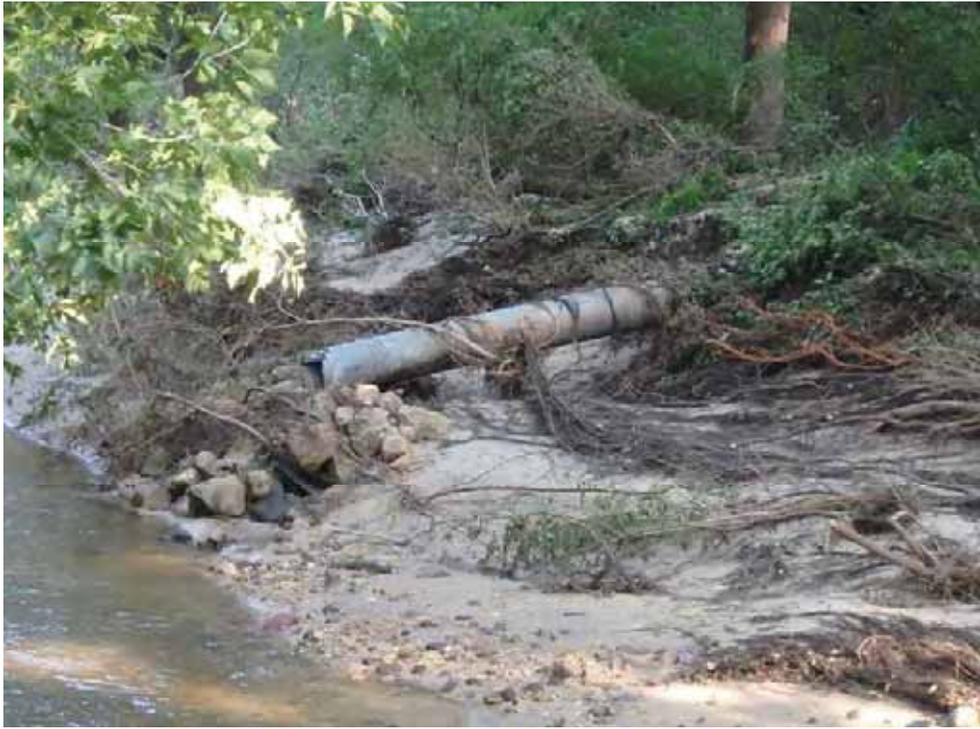
Photo 37. Photo of damaged stormwater outflow on mainstem of Pheasant Branch near Century Ave (August 25, 2018).

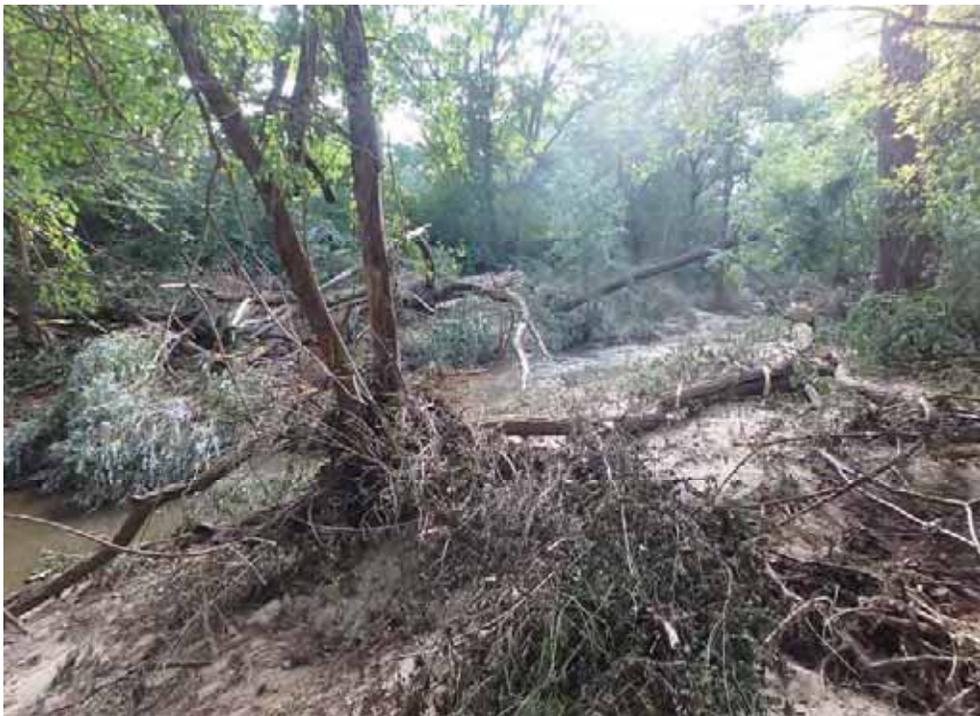
Photo 38. Photo of debris jam near Century Avenue on mainstem of Pheasant Branch (August 25, 2018).

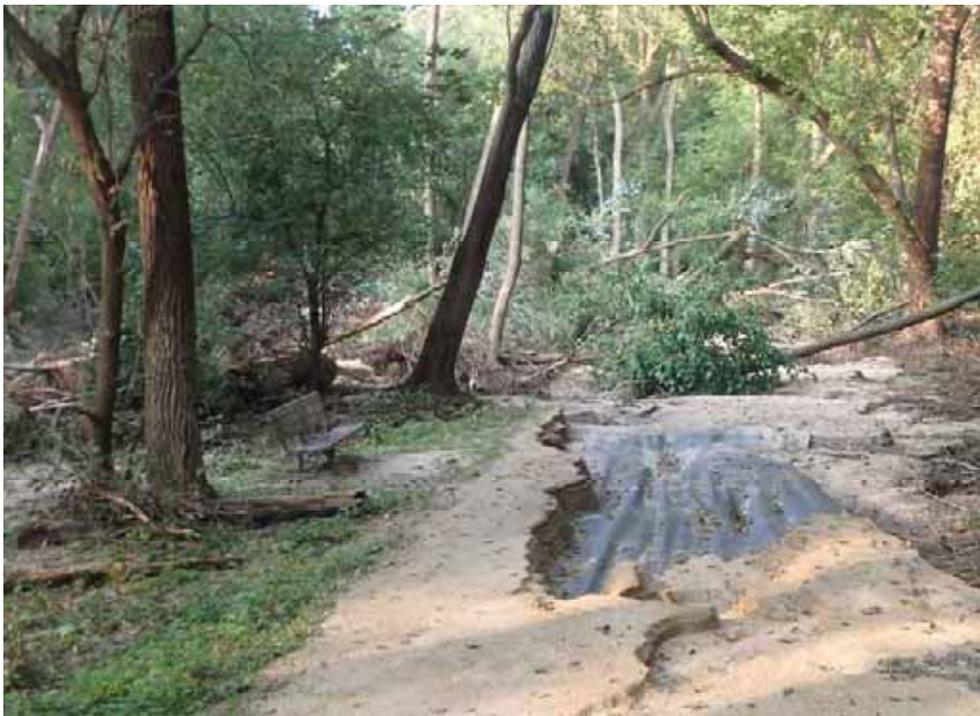
Photo 40. Photo of trail damage north of Century Ave (August 25, 2018).

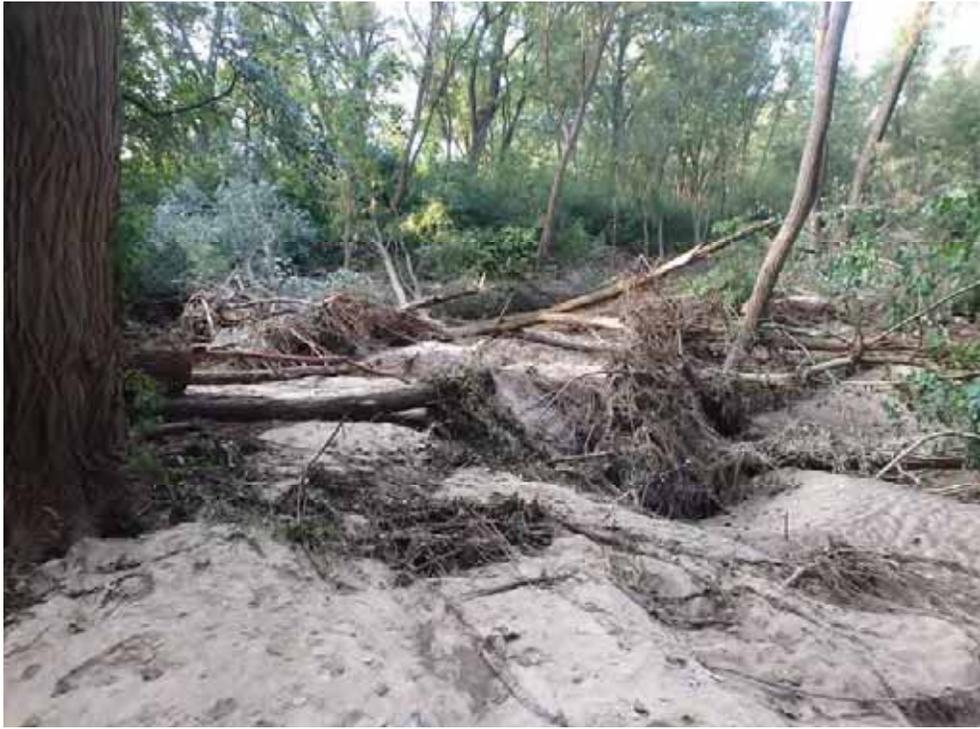
Photo 41. Photo of debris jam north of Century Ave on mainstem of Pheasant Branch (August 25, 2018).

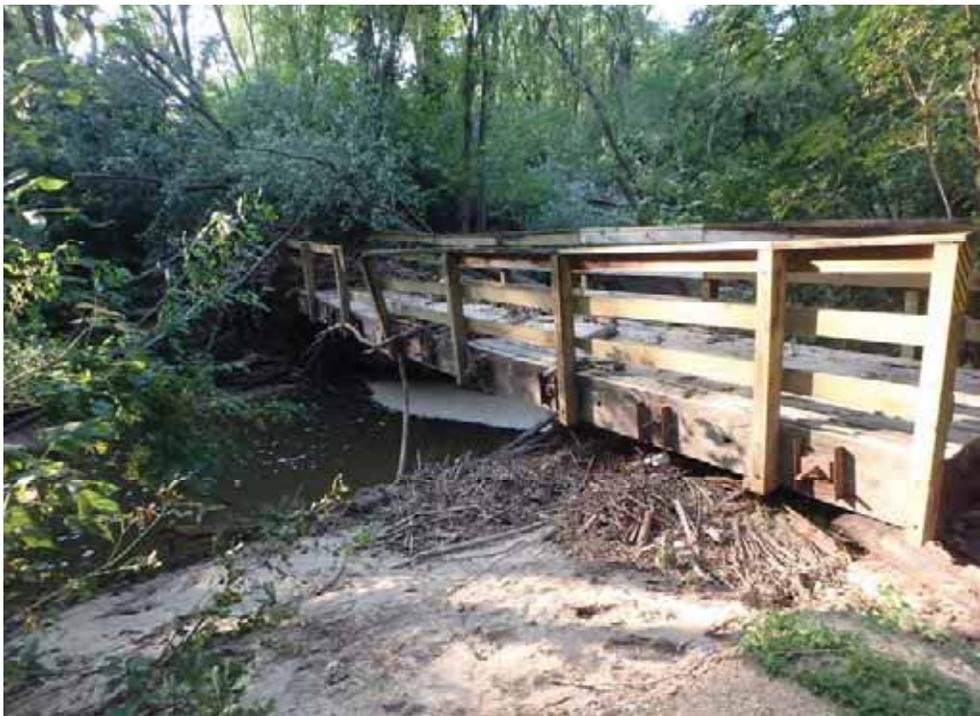
Photo 46. Photo of damaged bridge on mainstem of Pheasant Branch north of Century Ave (August 25, 2018).
