Pheasant Branch 2018 Flood Damage Assessment and Five Year Plan

City of Middleton

February 2019

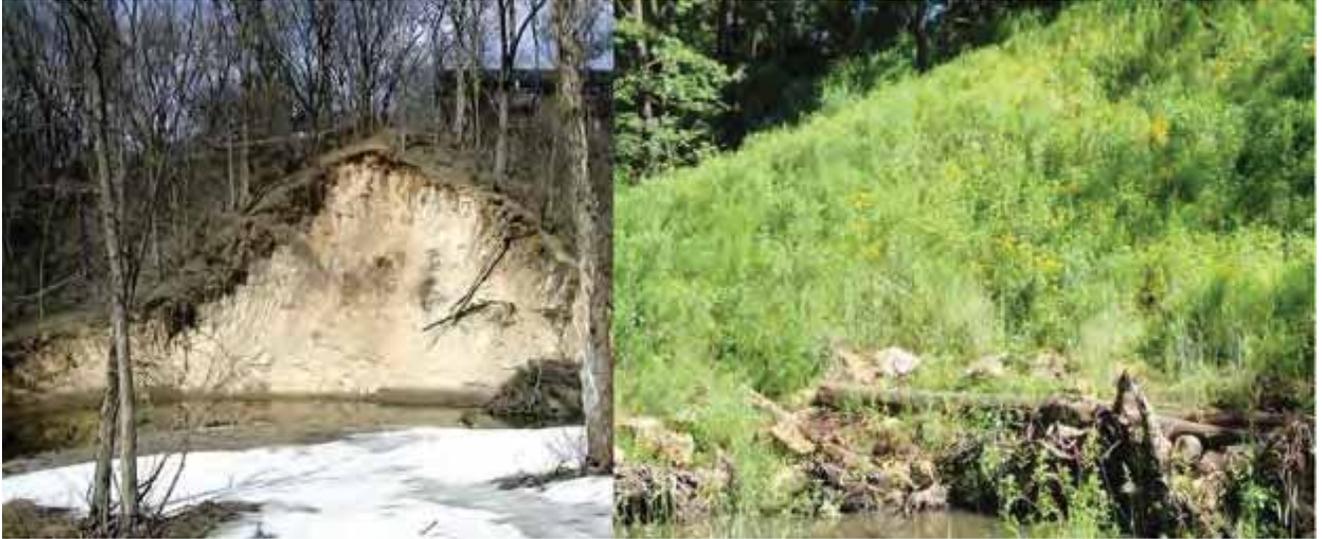
Figure 2: Photo of eroded slope adjacent to Pheasant Branch between Park St. and Century Ave. in 2005 (left) and same slope after construction taken in 2009 (right).

From 2007 to 2010, the City of Middleton performed approximately 2,000 linear feet of streambank and slope stabilization using ecologically-sensitive techniques including rootwad composites to protect the toe of the slopes and create additional deep pool and under-bank habitat. Slope grading was also performed on these slopes to bring them to a more stable angle and once completed the entire project areas were seeded with a mixture of native forbs and grasses. The dense growth and deep root systems of the native vegetation help to hold bank materials in place while allowing water to infiltrate through the soil instead of flowing overland to the stream (Figure 2).

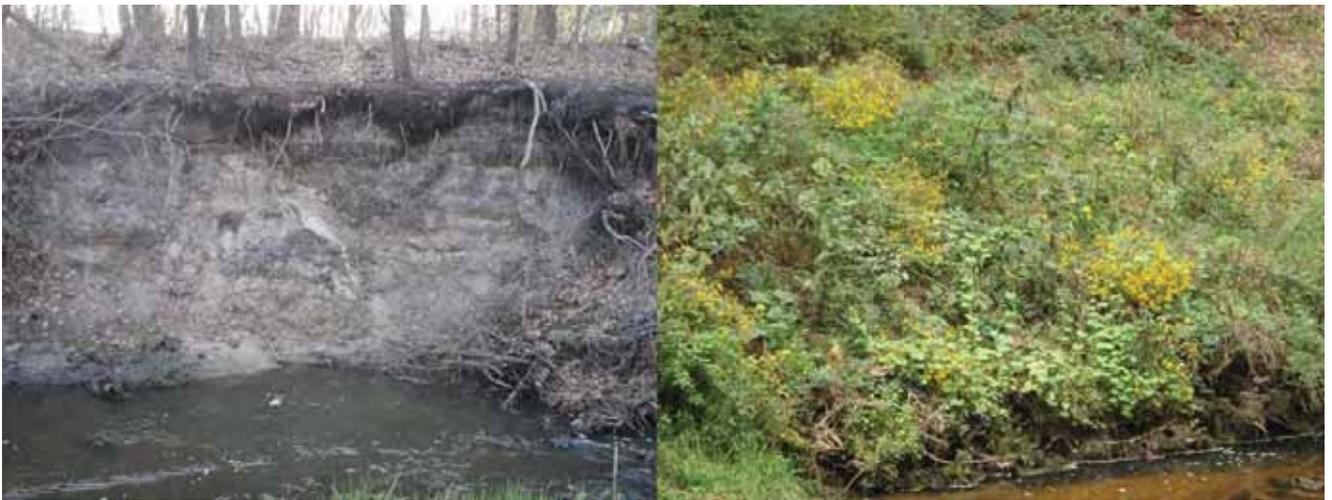
Figure 3: Photo of eroded slope adjacent to Pheasant Branch between Park St. and Parmenter St. in 2010 (left) and same slope after construction taken in 2014 (right).

In 2012, the City of Middleton stabilized nearly 1,500 linear feet of streambanks and slopes between Park St. and Parmenter St. within the Pheasant Branch corridor using ecologically-sensitive techniques to mitigate erosion. To reduce the sediment load in the creek, stream energy dissipation structures and integrated bank treatments, including rootwad and toewood composites, cross-vanes, and single arm vanes were installed. These methods stabilized the banks while providing improved habitat for the insects, amphibians, reptiles, and fish found within the creek and riparian corridor (Figure 3).

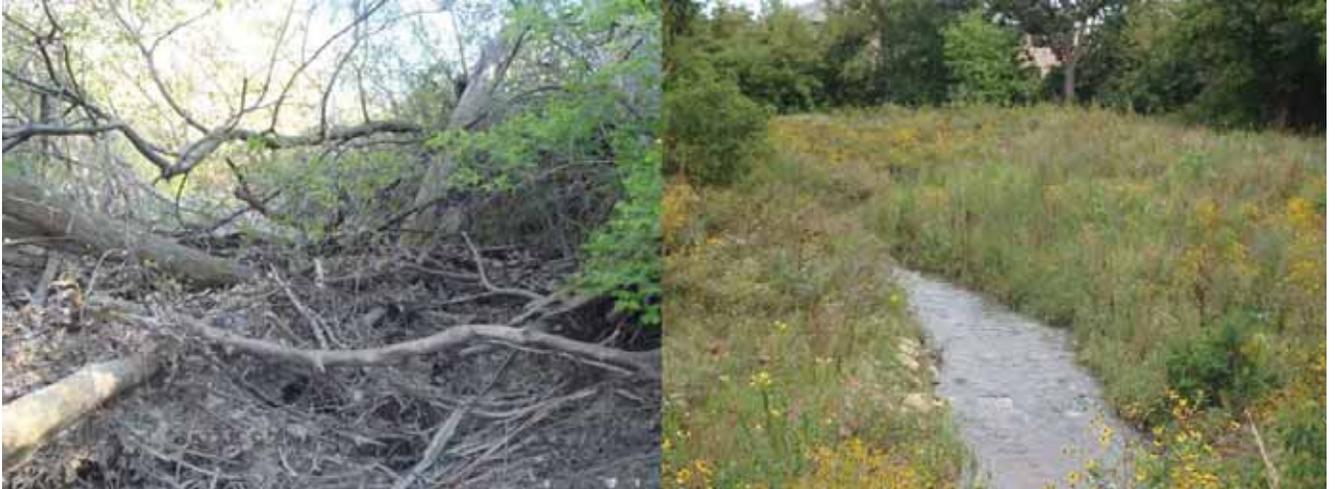
Figure 4: Photo of collapsing streambanks and debris jams within the south fork of Pheasant Branch in 2012 (left) and same section of stream after construction taken in 2015 (right).

In 2013, the City of Middleton completed nearly 1,000 linear feet of streambank stabilization in the south fork of Pheasant Branch between Greenway Blvd. and Market St. This project incorporated the re-use of trees that had to be removed from the site in order to grade collapsing streambanks. The trees were incorporated into the streambanks to provide extra bank protection, helping to dissipate stream energy by redirecting flows away from the banks while also providing valuable in-stream habitat for the riparian area. Bankfull benches were also graded into the new streambanks to allow high flows to get out of the channel and up onto the bench helping to dissipate stream energy through this reach during high flows (Figure 4).

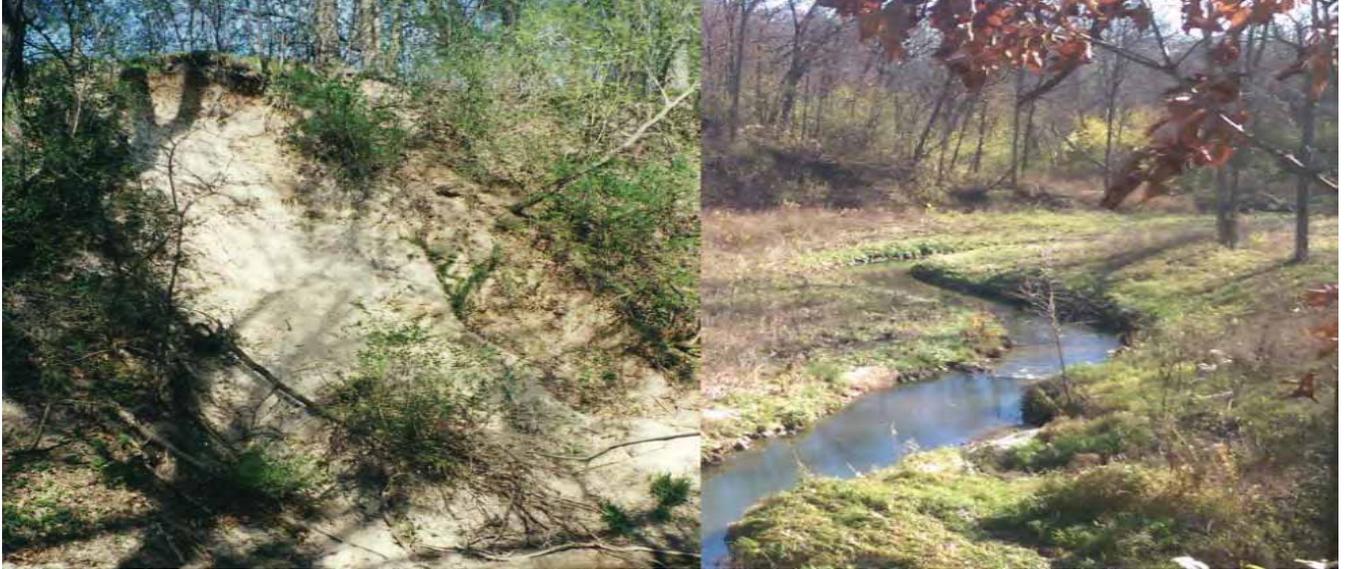
Figure 5: Photo of collapsing streambank adjacent to Pheasant Branch within near site of Kromrey Middle School addition 2013 (left) and same section of stream after construction taken in 2016 (right).

The Pheasant Branch Kromrey Middle School Stream Relocation Project relocated approximately 500 linear feet of stream channel away from steep eroding slopes and streambanks by creating a new channel using ecologically-sensitive techniques to mitigate erosion. Relocation of this section of stream also increased flood flow capacity at the site allowing flood flows to rise up out of the bankfull channel and spread out over a newly created floodplain, dissipating energy, and offering increased protection at the toe of the steep slope above which a new addition to the Kromrey Middle School was built. As part of the project, an additional 0.04 acres of backwater oxbow wetland was created (Figure 5).

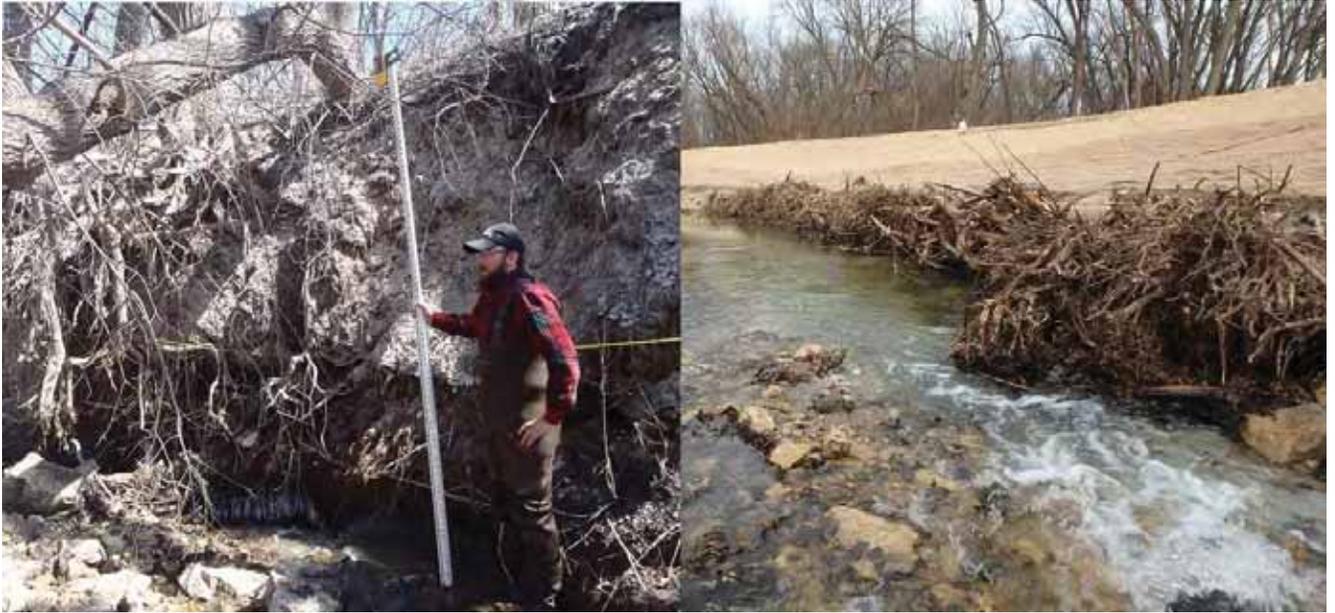
Figure 6: Photo of collapsing streambank adjacent to Pheasant Branch located North of Century Ave. in 2014 (left) and same section of stream after construction taken in 2017 (right).

In 2017 the City of Middleton stabilized over 1,000 linear feet of severely eroding streambanks and eroded steep slopes using ecologically-sensitive techniques along Pheasant Branch north of Century Ave. The eroding streambanks and eroded slope locations varied in size, extent of active erosion, and in applicable treatment. Trees removed during restoration activities to grade streambanks and collapsing slopes to more stable angles and increase flood flow capacity of the channel within the project area were re-used in streambank stabilization treatments. These treatment techniques incorporated the removed woody material as part of the bank stabilization (Figure 6).

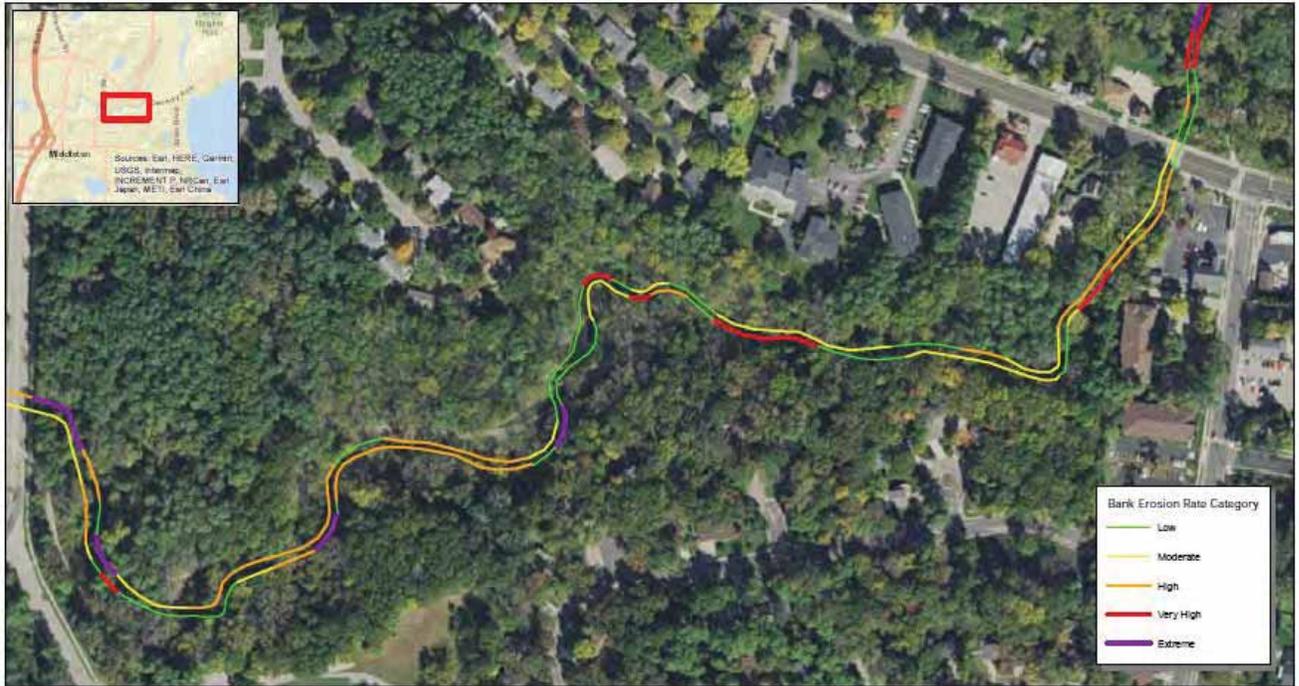
Cardno performed a complete streambank erosion assessment of both the left and right bank for the north fork, south fork and mainstem of Pheasant Branch. Streambank erosion assessments were performed using the Bank Erosion Hazard Index (BEHI) model developed by Dr. David Rosgen². The BEHI model evaluates the susceptibility of a streambank to erosion for multiple erosional processes. Individual BEHI variables are recorded through visual assessments and physical measurements to determine the combined risk for specific streambank sections to future streambank erosion (Figure 10).

Figure 10: Example BEHI model streambank erosion risk assessment for mainstem of Pheasant Branch between Park St. and Century Ave.

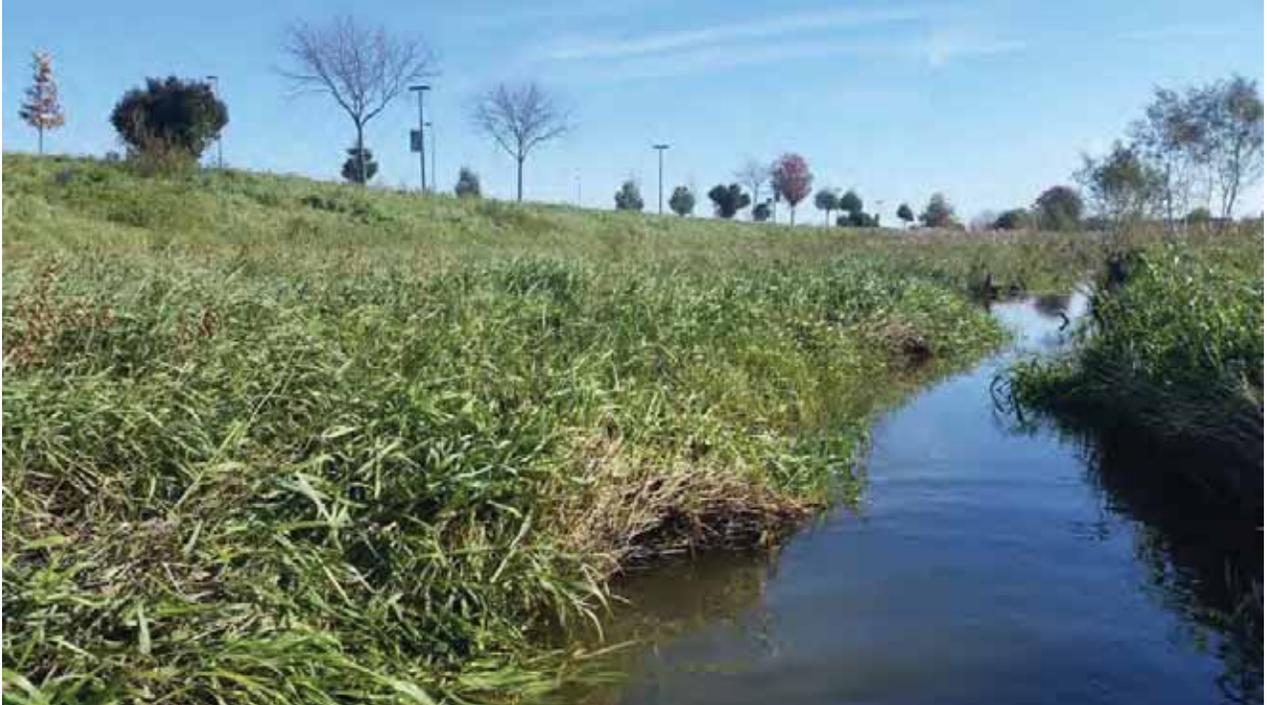
The north fork of Pheasant Branch came through the August 2018 flood with relatively low damage and lasting streambank erosion. This is evident in BEHI model bank assessments for this area with no streambanks in this region showing High, Very High, or Extreme rates of bank erosion. The stream in much of the north fork of Pheasant Branch has access for flood waters to rise out of the channel onto the flood plain, which helped dissipate energy during the August 2018 flood event (Figure 11). The lack of shallow rooted tree species near the channel in this area also helped mitigate flood damage as uprooted downed trees in other areas caused extensive damage.

Figure 11: Post-flood photo of the north fork of Pheasant Branch viewing downstream (10/22/18).

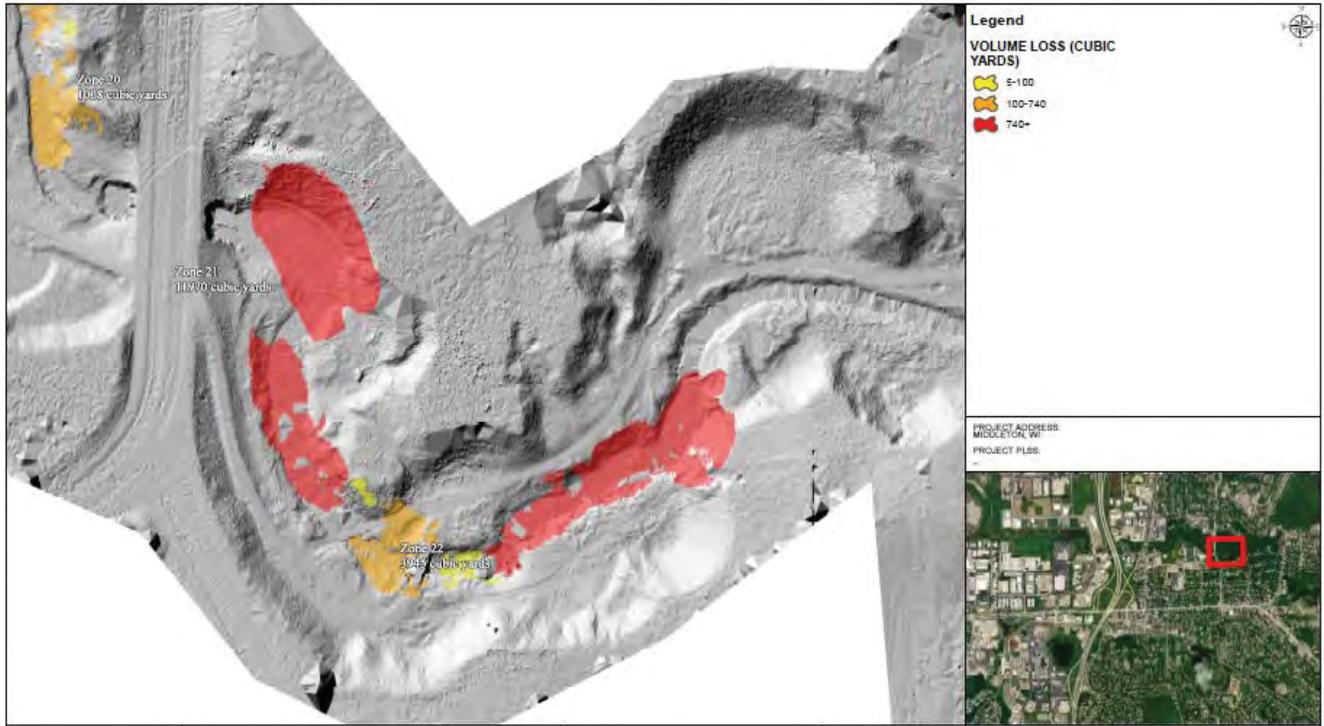
As part of the August 2018 flood damage assessment, Cardno sub-contracted Wisconsin Environmental Restorations, LLC to fly the north fork, south fork, and mainstem of Pheasant Branch with a drone and record up-to-date LiDAR measurements of the channel. LiDAR information collected during these drone flights was then compared with 2017 LiDAR data acquired from Dane County to provide an assessment of streambank sediment lost during the August 2018 flood event (Figure 23).

Figure 23: Example of comparison between 2017 and 2018 LiDAR data directly downstream of Park St. on the mainstem of Pheasant Branch.

A complete analysis of the differences between the 2017 and 2018 LiDAR data sets for the north fork, south fork, and mainstem of Pheasant Branch can be found in Appendix D. Initial estimates of sediment loss throughout the Pheasant Branch corridor total approximately 55,000 to 60,000 cubic yards of sediment lost from the channel and streambanks during the August 2018 flood event. Areas where no detectable change occurred indicated by no color in the sediment loss analysis maps (Figure 23 and Appendix D) does not necessarily mean no appreciable loss of the streambank and channel material occurred. For data analysis purposes, a “no change” scenario resulted when there was less than 1 foot vertical separation from pre-flood to post-flood land surfaces. Underlying noise common to all LiDAR datasets resulting from a number of factors such as auto/manual classification of LiDAR data points limited the initial analysis. A more detailed analysis could be performed on the two data sets to refine a sediment loss estimate; however this would require extensive cross section analysis of at least 300 locations and is outside of the scope of this report.

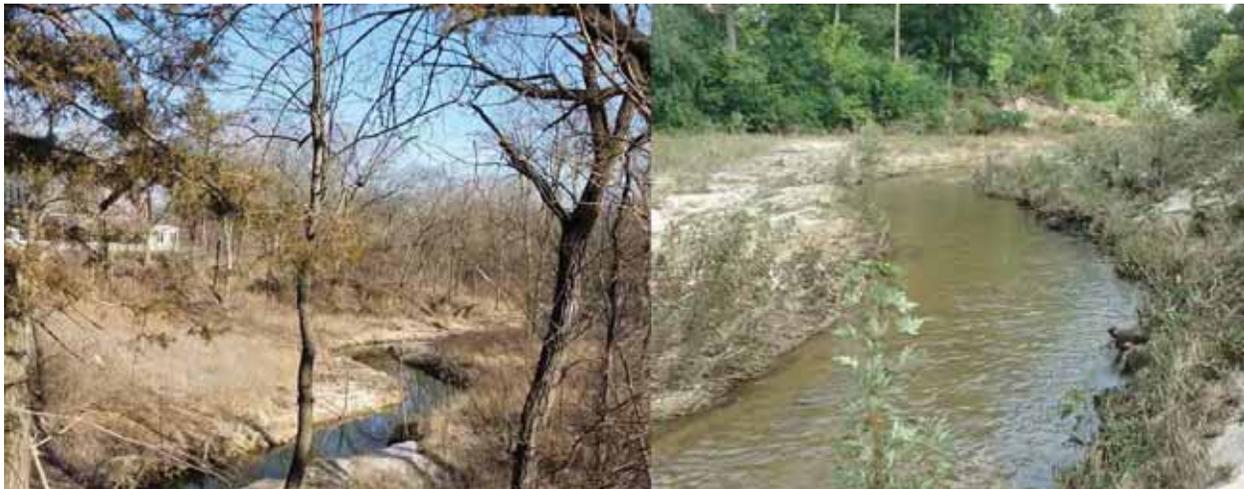
One of the areas that made it through the August 2018 flood event with little damage was approximately 500 linear feet of relocated channel near the Kromrey Middle School constructed in 2015. Relocation of this section of stream between Parmenter St. and Park St. increased flood flow capacity at the site allowing flood flows to rise up out of the bankfull channel and spread out over a newly created floodplain area to dissipate stream energy while offering increased protection at the toe of the steep slope above which a new addition to the Kromrey Middle School was built (Figure 24).

Figure 24: Photo of relocated section of Pheasant Branch in 2017 (left) and same section of stream after 2018 flooding taken on 8/25/18.

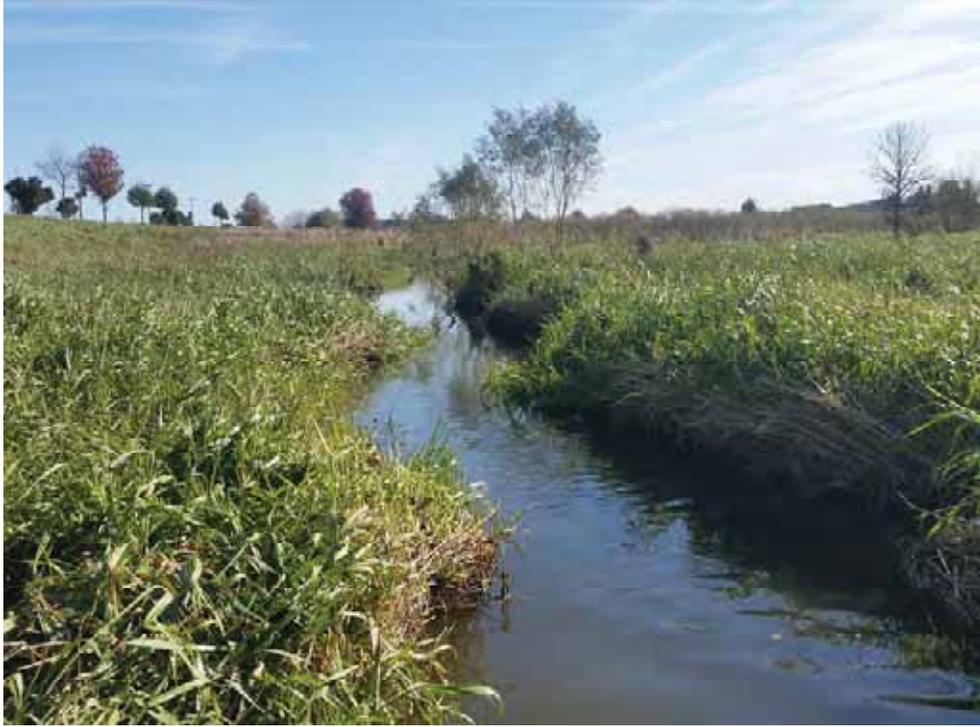
Photo 1. Post August 2018 flood photo of the north fork of Pheasant Branch viewing downstream. (October 22, 2018).

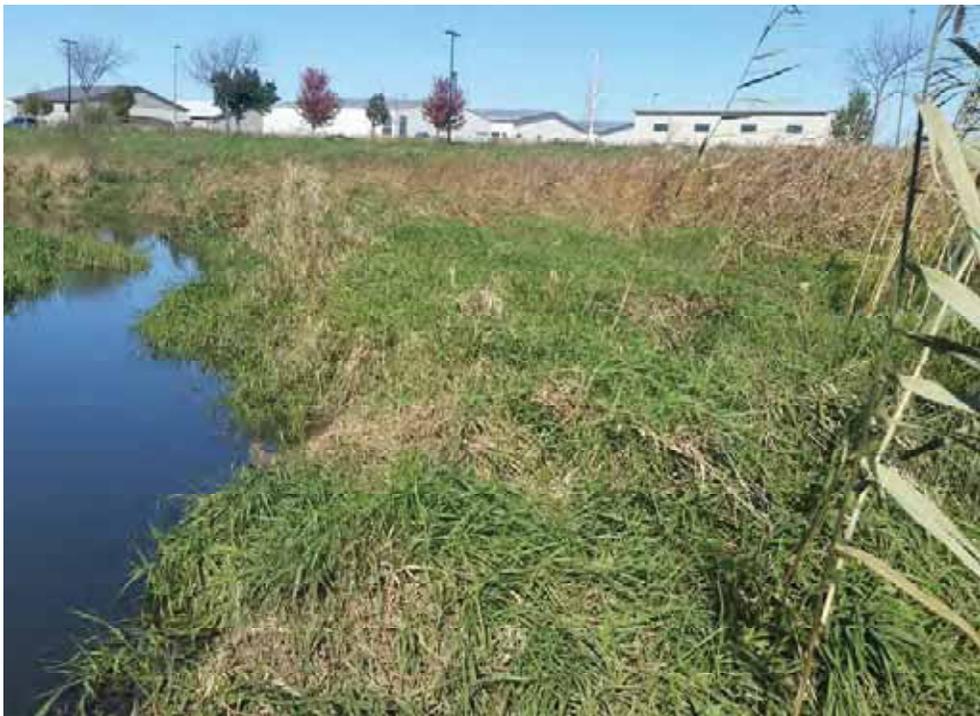
Photo 2. Post August 2018 flood photo of the north fork of Pheasant Branch viewing upstream. (October 22, 2018).

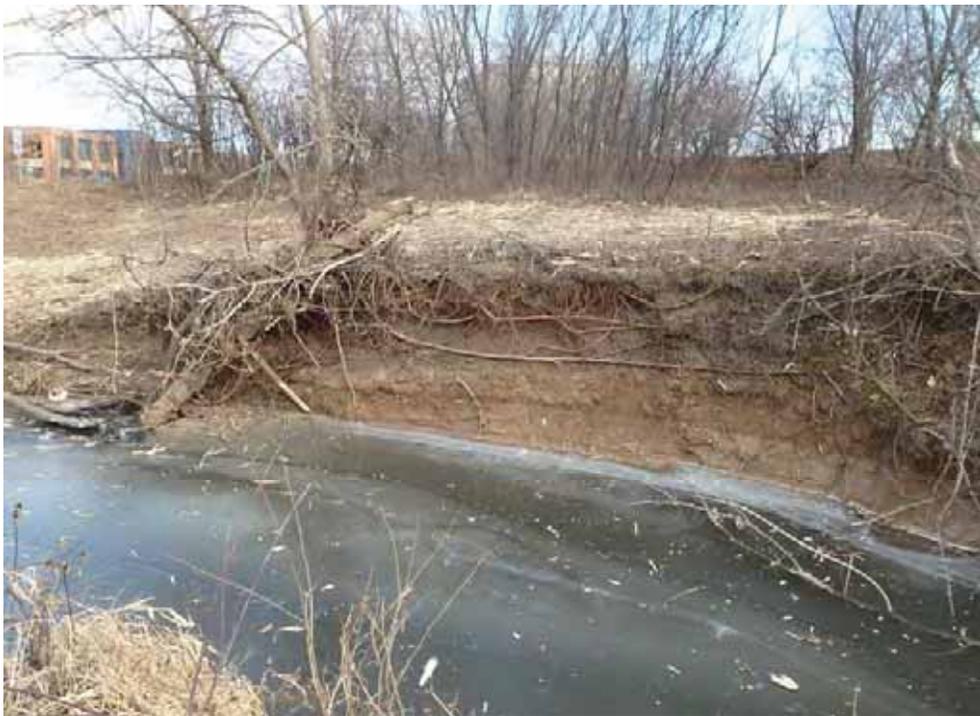
Photo 6. Photo viewing extreme streambank erosion on south fork of Pheasant Branch east of Greenway Boulevard (January 16, 2019).

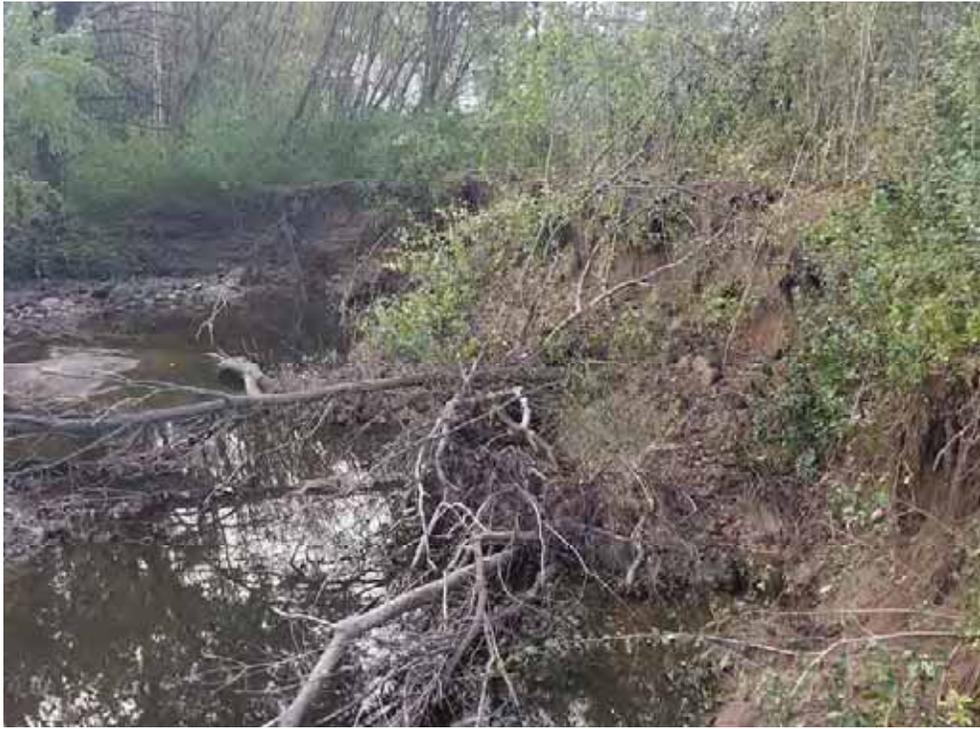
Photo 7. Photo of collapsing streambank on the south fork of Pheasant Branch viewing upstream (October 16, 2018).

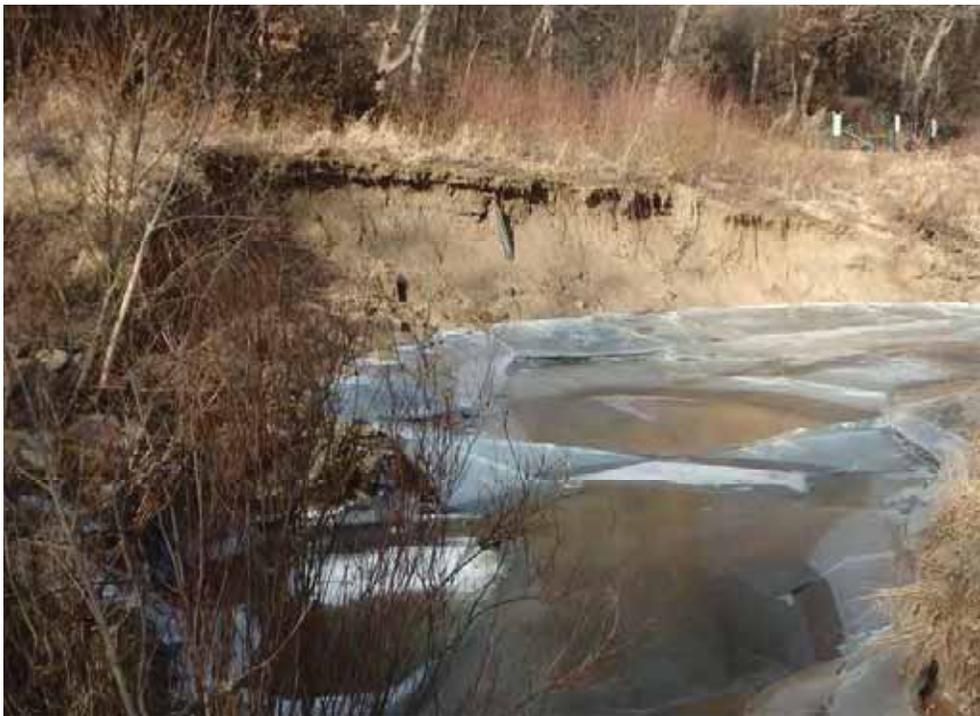
Photo 8. Photo of extreme streambank erosion on south fork of Pheasant Branch viewing downstream (January 16, 2019).

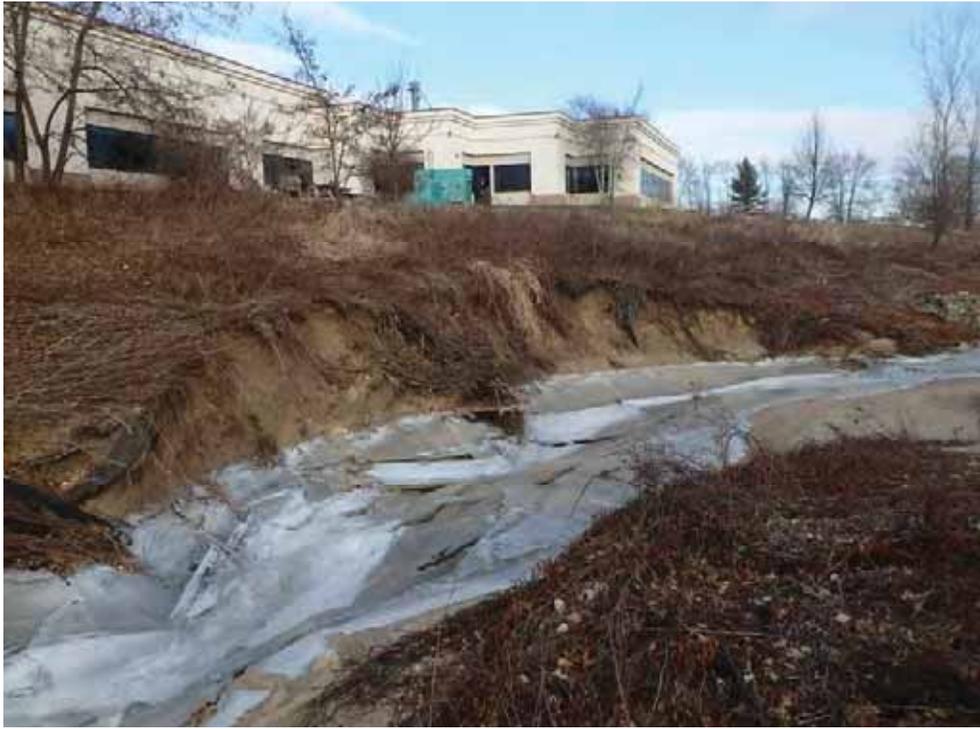
Photo 9. Photo of extreme streambank erosion on the south fork of Pheasant Branch viewing downstream (January 16, 2019).

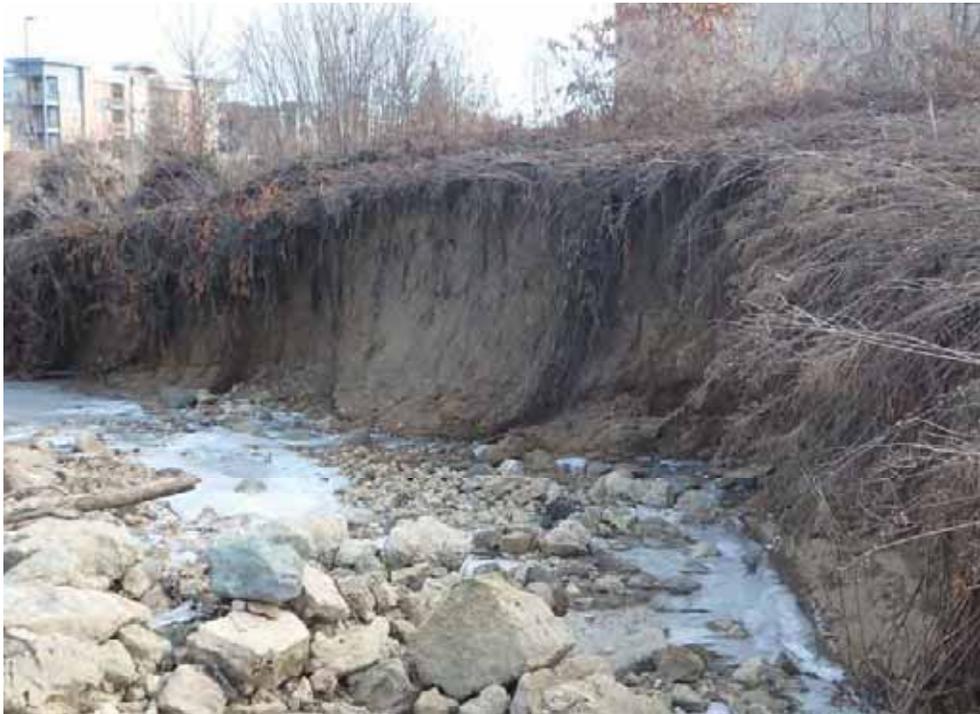
Photo 10. Photo of extreme streambank erosion on south fork of Pheasant Branch near Market Street viewing downstream (January 16, 2019).

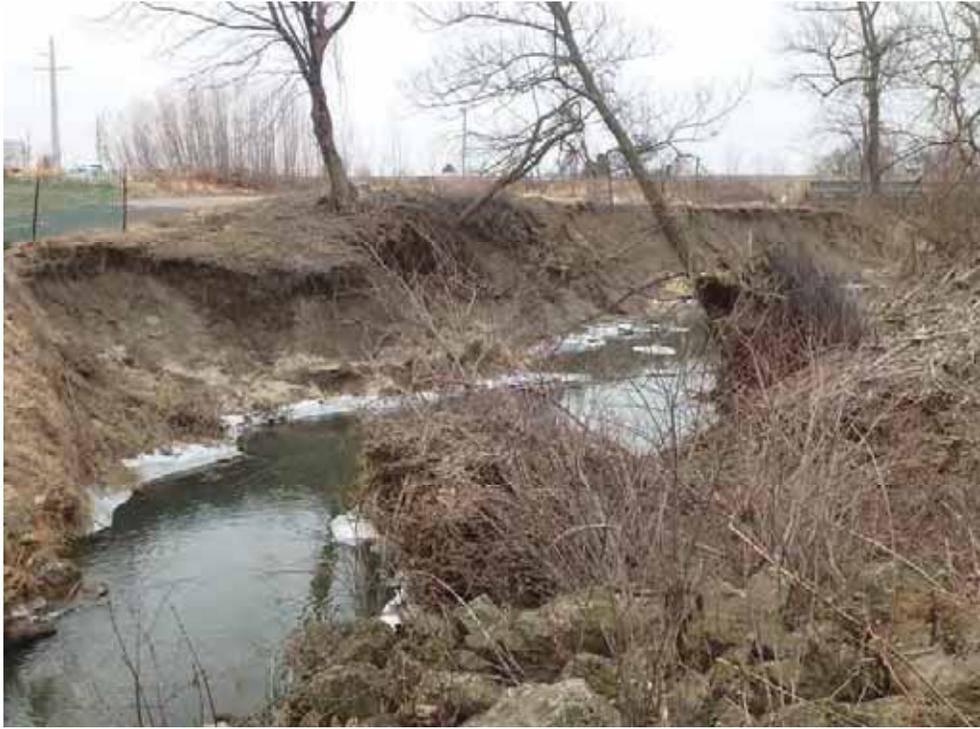
Photo 11. Photo of extreme streambank erosion on the mainstem of Pheasant Branch viewing downstream (January 15, 2019).

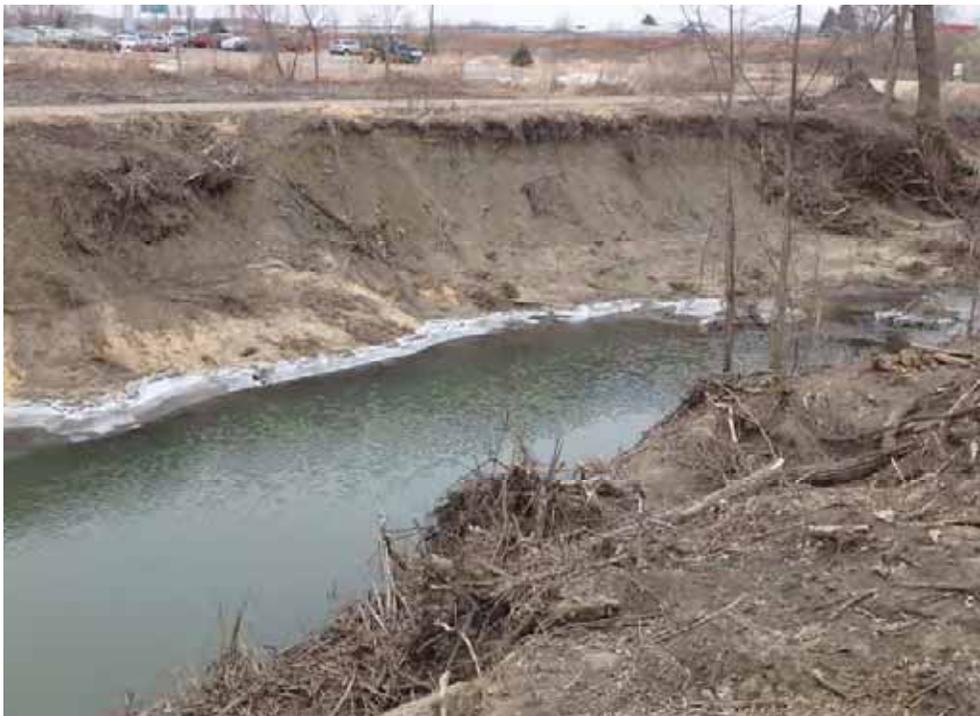
Photo 12. Photo of extreme streambank erosion on the mainstem of Pheasant Branch viewing downstream (January 15, 2019).

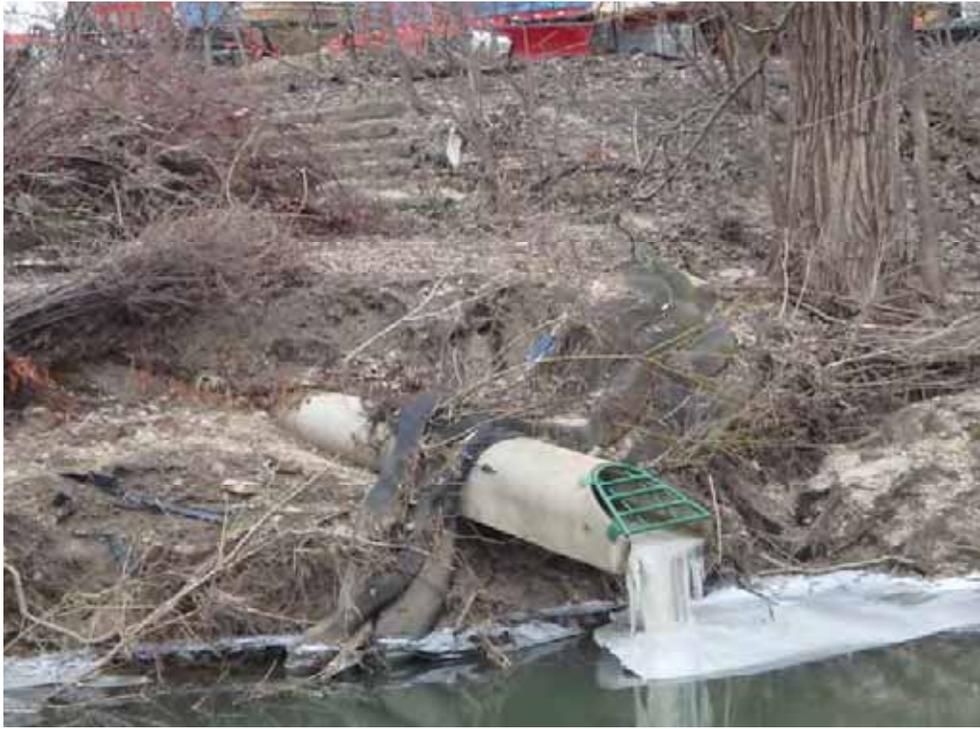
Photo 13. Photo of erosion near stormwater outlet on mainstem of Pheasant Branch viewing downstream (January 15, 2019).

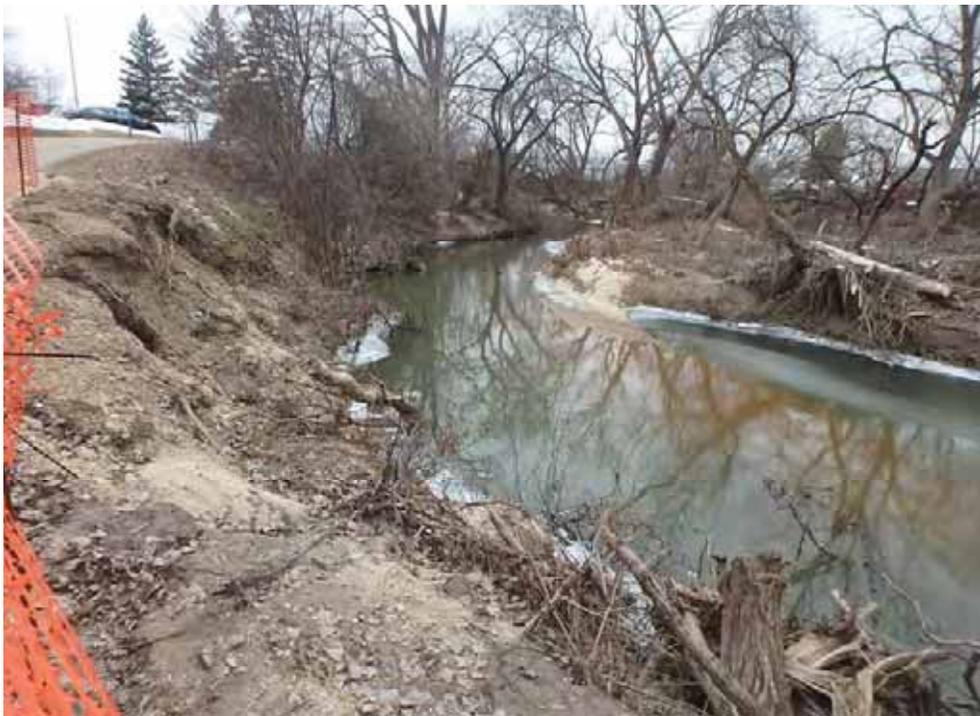
Photo 14. Photo of very high streambank erosion on the mainstem of Pheasant Branch near Parmenter Street viewing upstream (January 15, 2019).

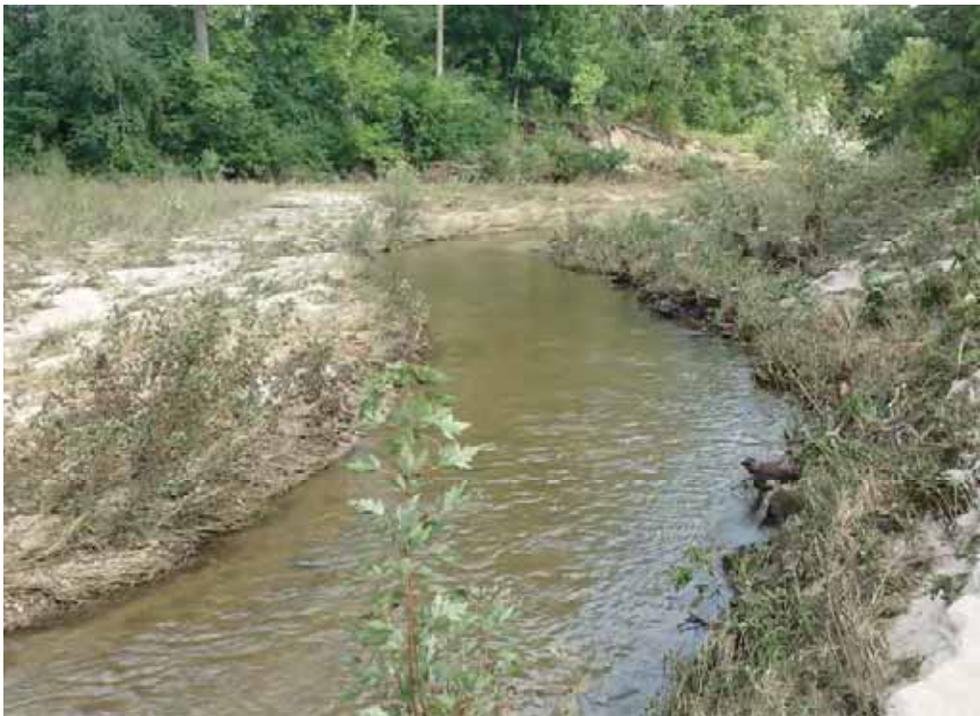
Photo 22. Photo of relatively undamaged area of Kromrey stream relocation project on mainstem of Pheasant Branch (August 25, 2018).

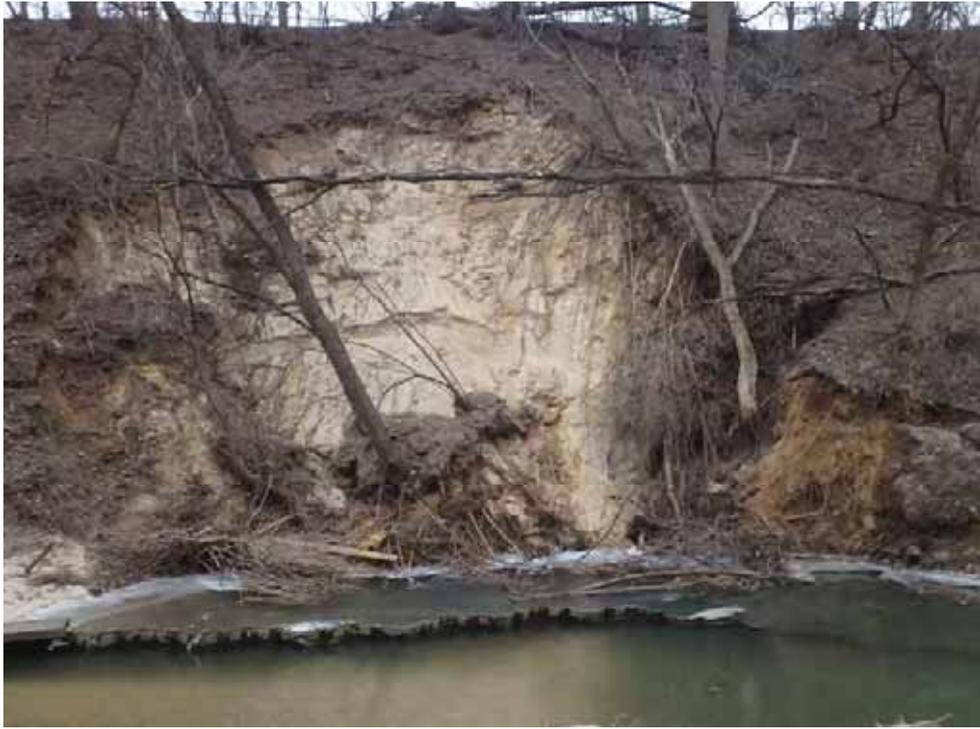
Photo 25. Photo of collapsed bank directly behind sheet-piling mainstem Pheasant Branch near Park Street (January 15, 2019).

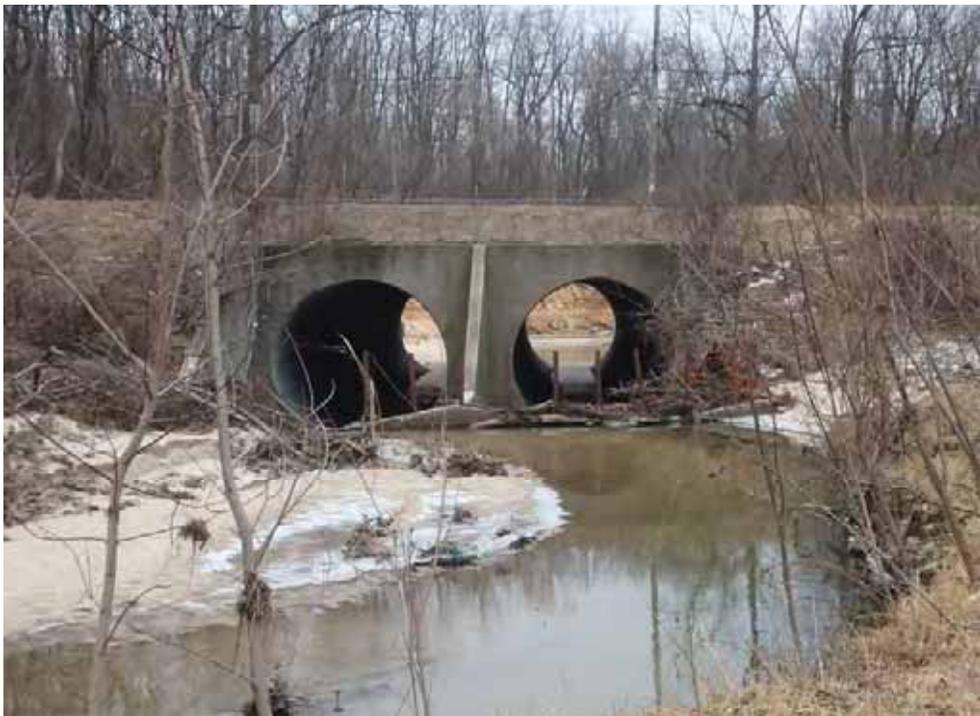
Photo 26. Photo of undersized stream crossing and fish passage impediment beneath Park Street. (January 15, 2019).

- Replacement of under-sized pedestrian bridges found throughout the Pheasant Branch corridor with larger bridges that provide additional capacity for flood flows and debris flows during flooding events.
- Mitigation of barriers to upstream migration of fish in the mainstem of Pheasant Branch through retro-fitting of fish passage structures to aid fish passage over and through current migration barriers and/or replacement of fish passage barriers such as the stream crossing underneath Park St.

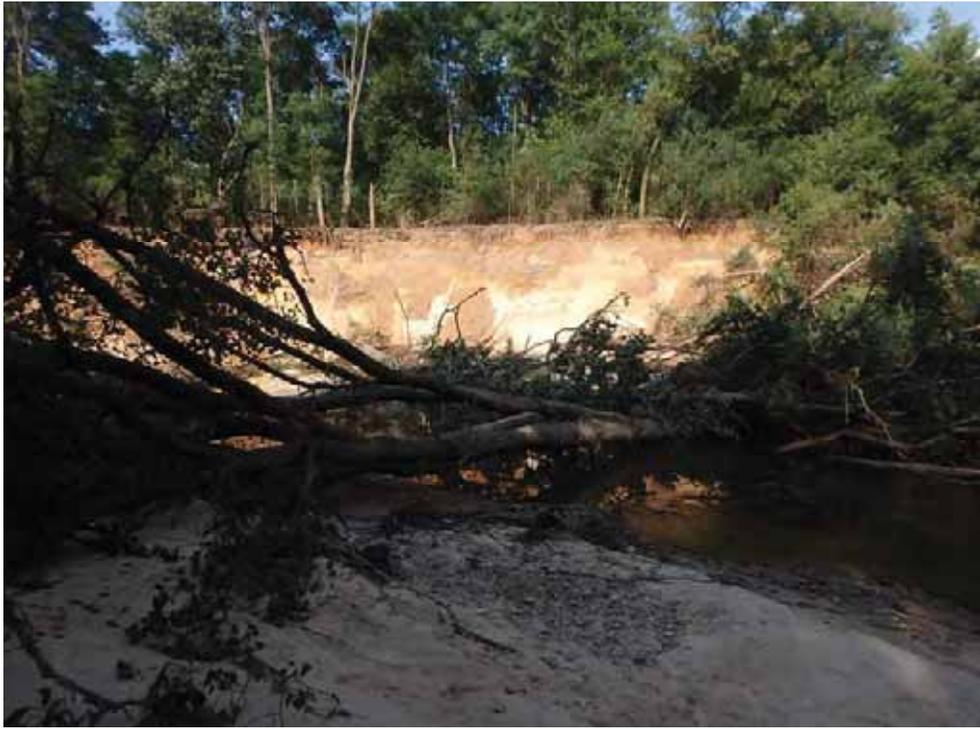
Photo 27. Photo of collapsed bank directly downstream of Park Street on mainstem Pheasant Branch near Park Street (August 25, 2018).

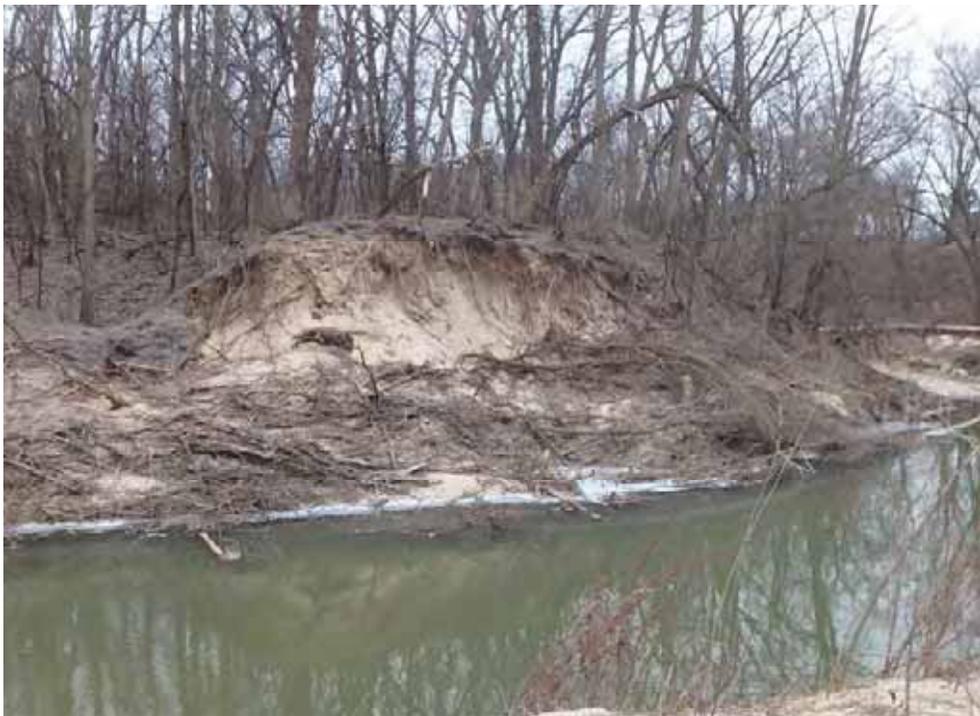
Photo 28. Photo of streambank erosion near first bridge crossing on mainstem of Pheasant Branch downstream of Park Street. (January 15, 2019).

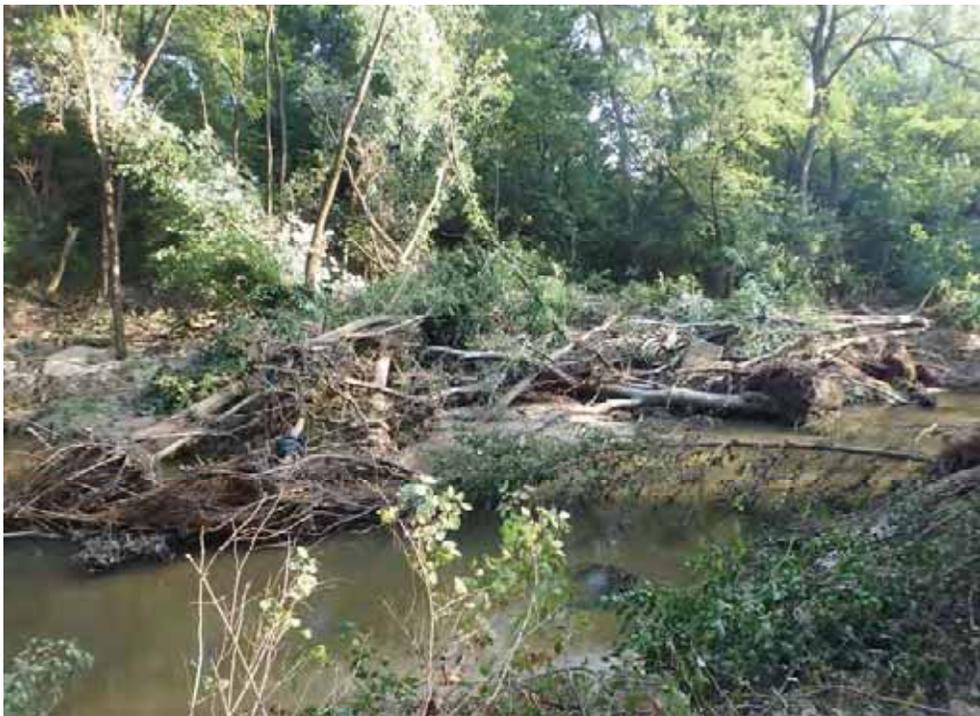
Photo 34. Photo of debris jam between Park Street and Century Avenue on mainstem of Pheasant Branch (August 25, 2018).

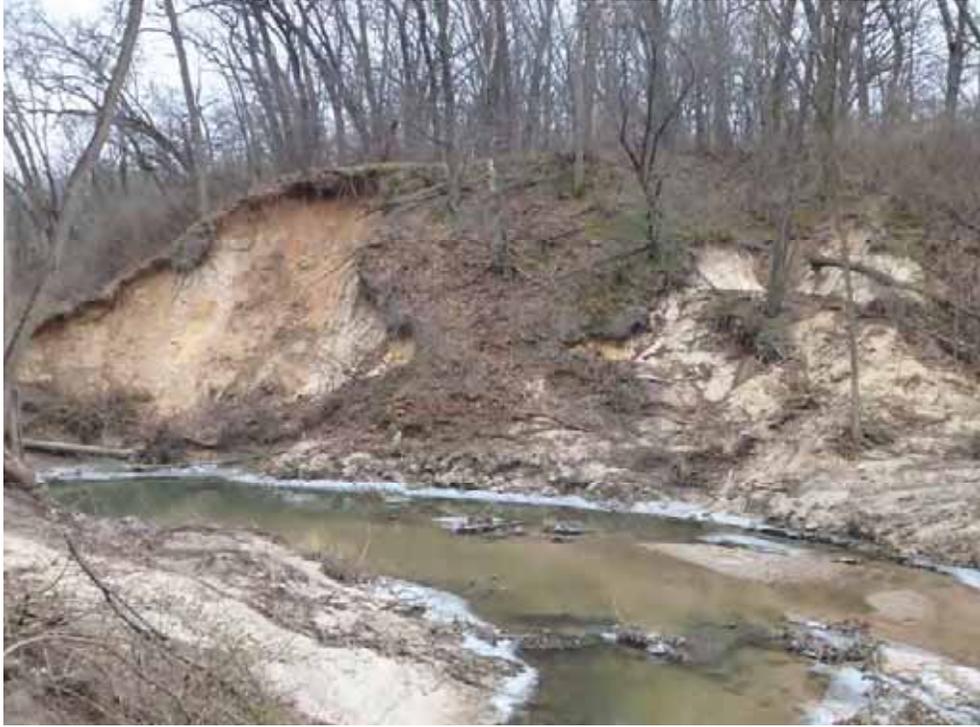
Photo 35. Photo of streambank erosion between Park Street and Century Ave on mainstem of Pheasant Branch (January 15, 2019).
