Pheasant Branch 2018 Flood Damage Assessment and Five Year Plan

City of Middleton

February 2019

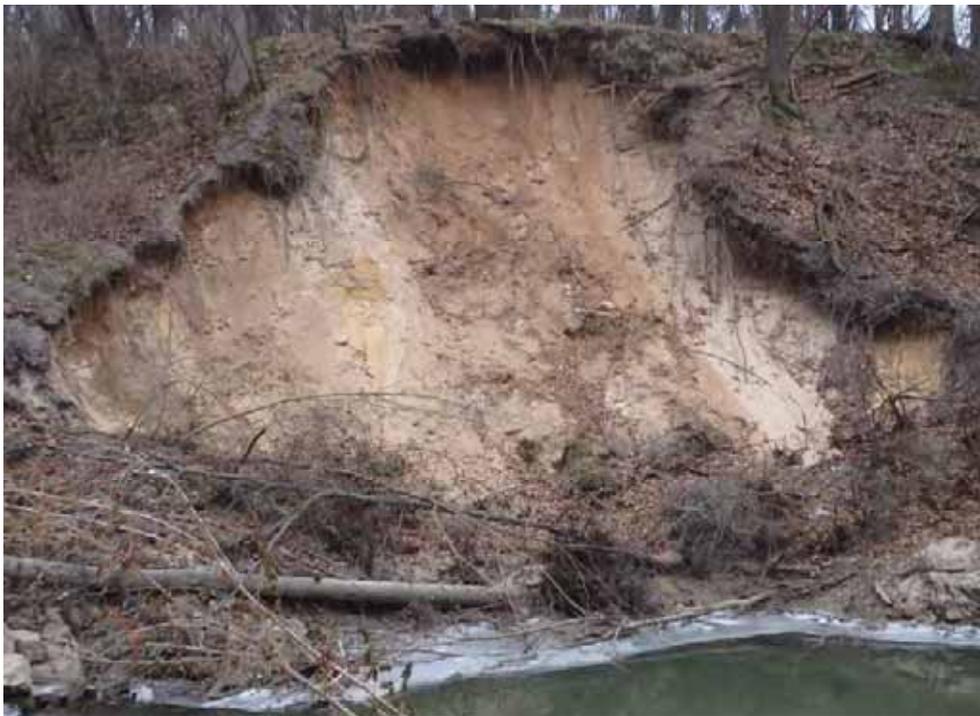
Photo 36. Photo of collapsed slope between Park Street and Century Avenue on mainstem of Pheasant Branch (January 15, 2019).

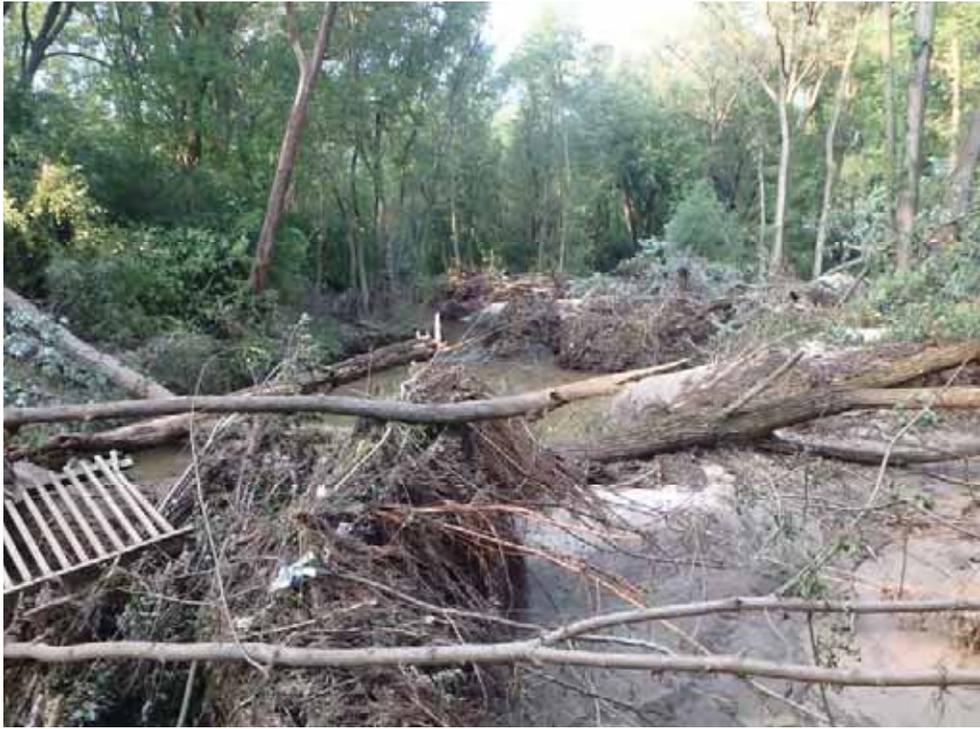
Photo 39. Photo of debris jam on mainstem of Pheasant Branch near Century Ave (August 25, 2018).

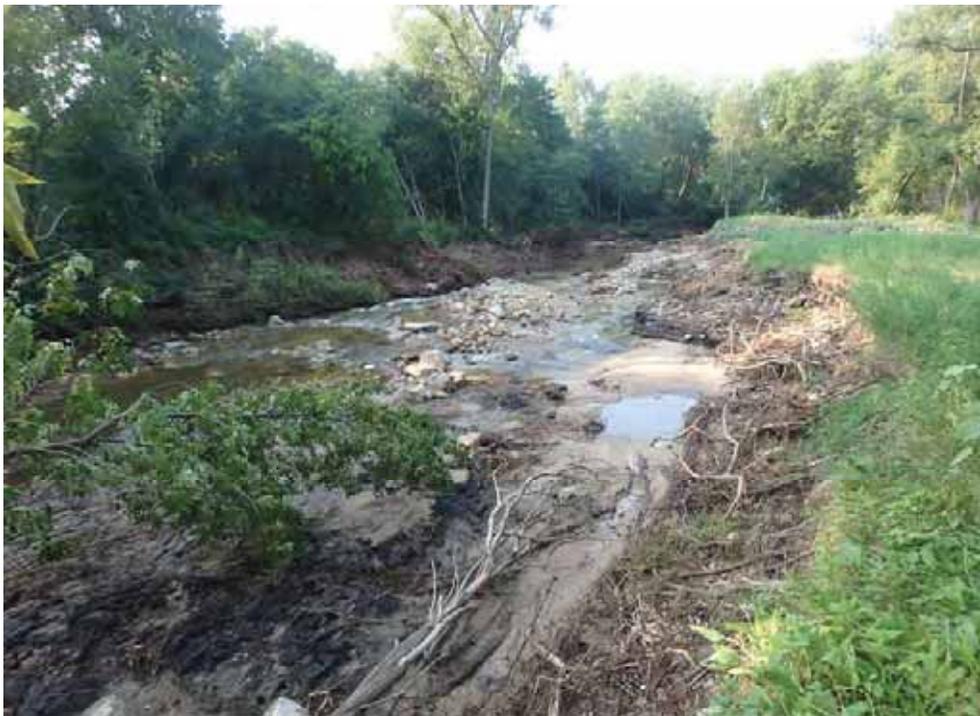
Photo 42. Photo of streambank erosion downstream from Century Ave on mainstem of Pheasant Branch (August 25, 2018).

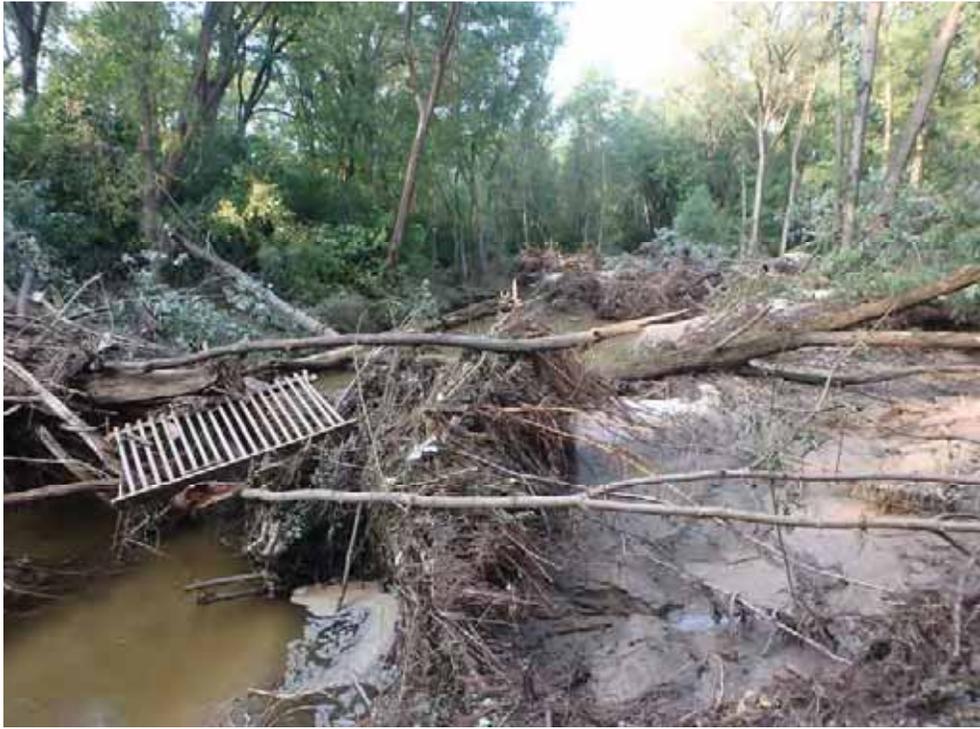
Photo 43. Photo of debris jam on mainstem of Pheasant Branch (August 25, 2018).

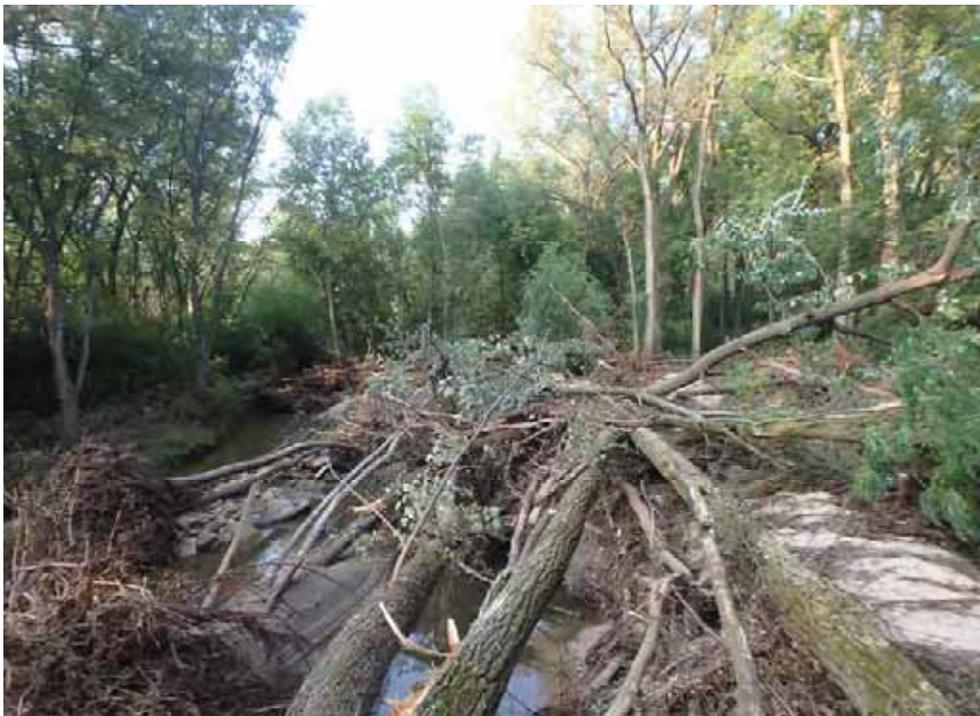
Photo 44. Photo of another debris jam near on mainstem of Pheasant Branch (August 25, 2018).

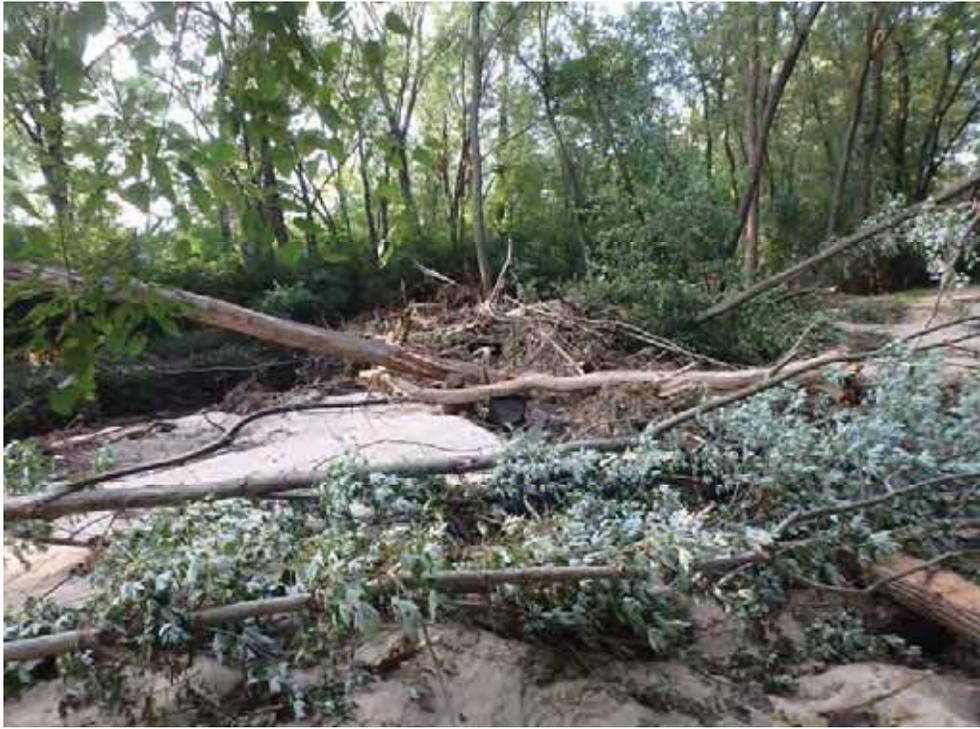
Photo 45. Photo of debris jam upstream of bridge crossing on mainstem of Pheasant Branch north of Century Ave (August 25, 2018).
